JUNE 2014

Analysis of Pressures and Impacts on runoff water quality for the Oroklini Lake catchment

Specific task as part of the project LIFE10 NAT/CY/716 where BirdLife Cyprus is an associated beneficiary

Final Report

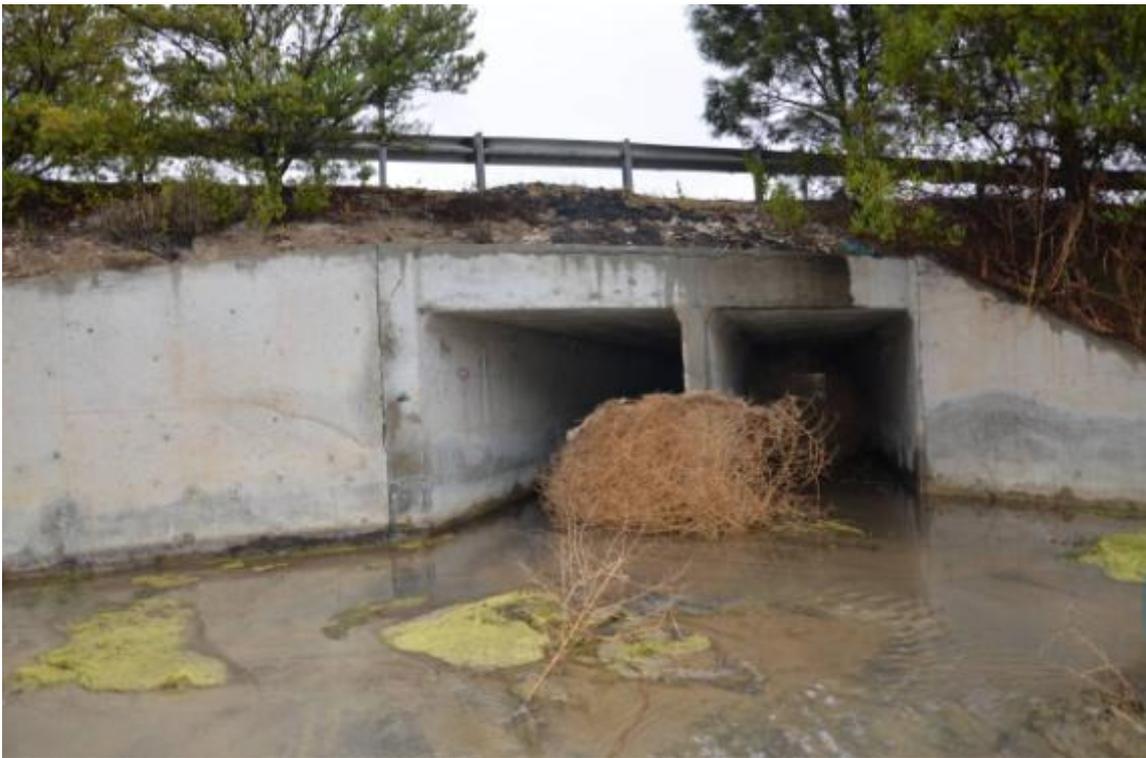
The Photo 2-1, taken on the 6th of May 2014 during a storm, shows the exit of the box culvert under the Highway.

Photo 2-1: Stream flow towards the Lake on the 6th of May 2014. Drainage of highway runoff may also be noted

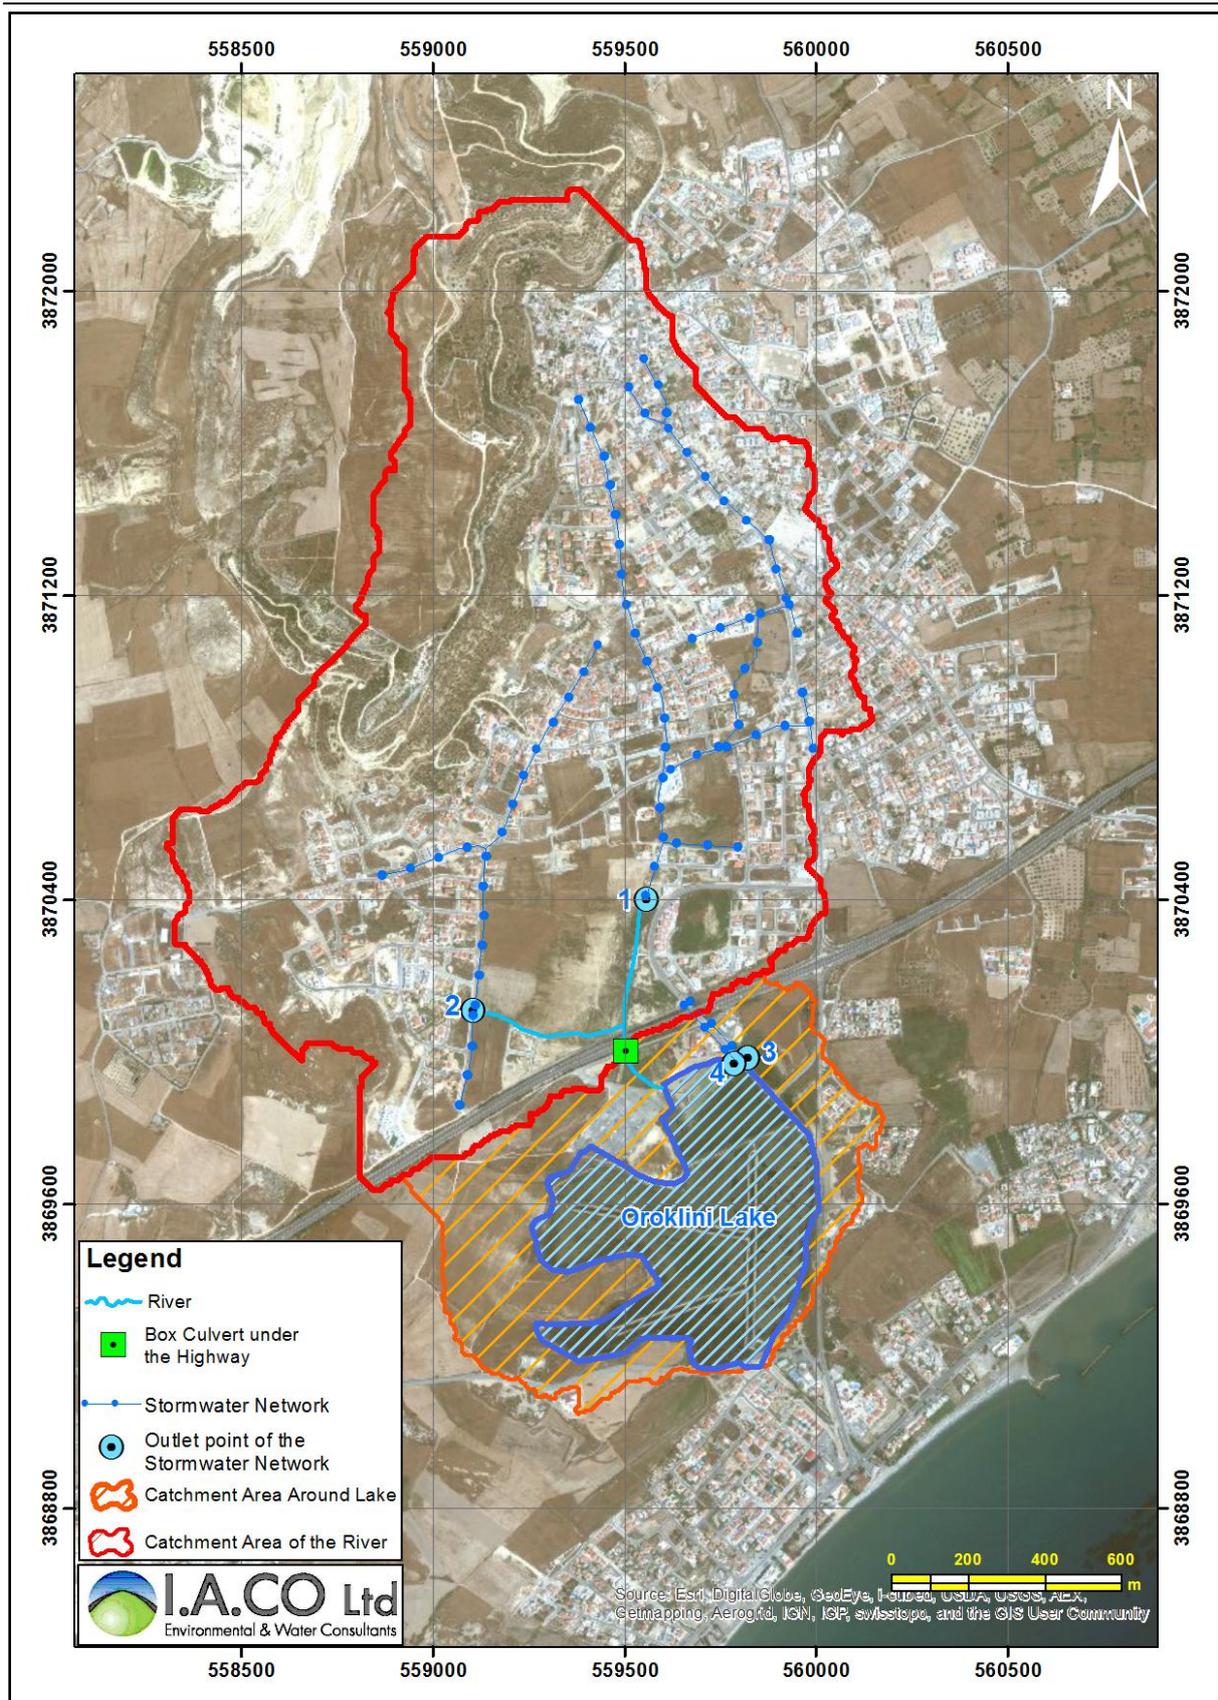
The storm-water network of Oroklini is shown on Map 2.3. This is divided into two parts: the central one with an outlet of 120 cm culvert diameter and the western part with an outlet of 100 cm culvert diameter. The whole network is within the catchment area that discharges into the Lake. It should be noted that there is no officially registered stream by the Land Registry Department and thus no stream appears on the Cadastral maps. As a result, the natural stream has been tampered with by the urbanization and most of the flow is currently carried through the stormwater network.

Map 2-3. Extent of the storm-water network at Oroklini Village

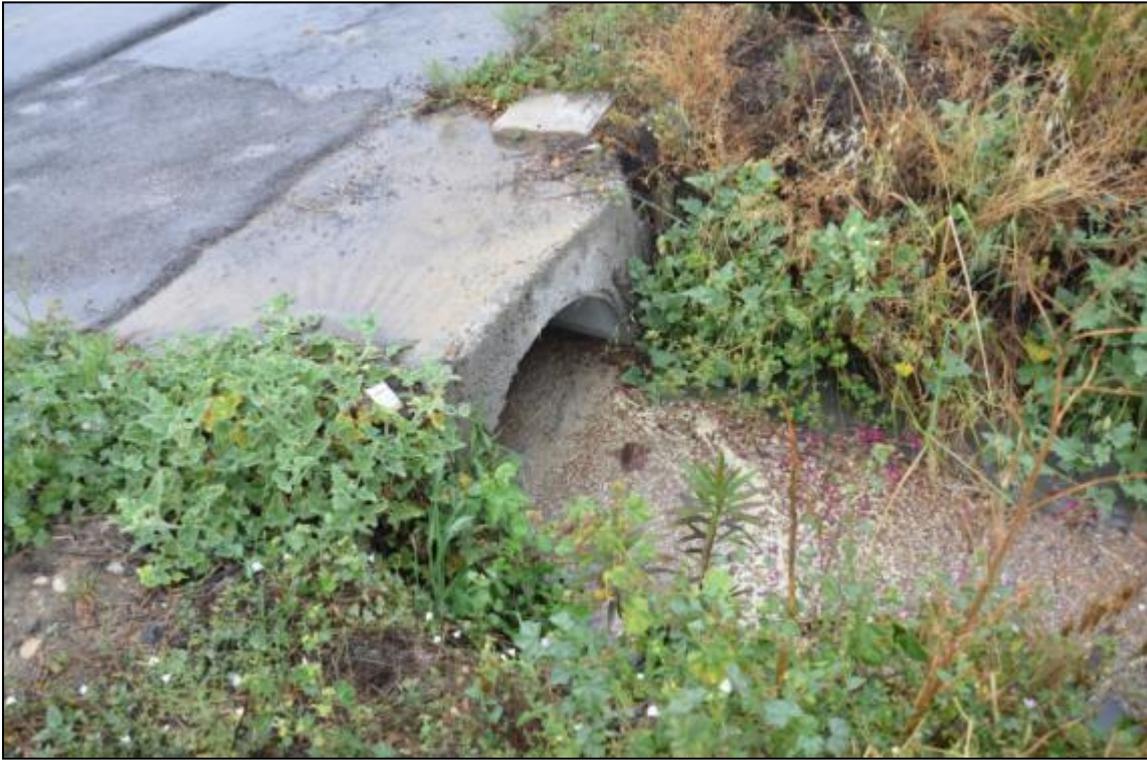
Photo 2-2, taken on the same day as above, shows the 100 cm diameter storm-water outlet of the western section of the network flowing towards the culvert under the Highway (point 2 on Map 2-3).

Photo 2-2. Storm-water outlet of 100cm diameter, of the western section of the network

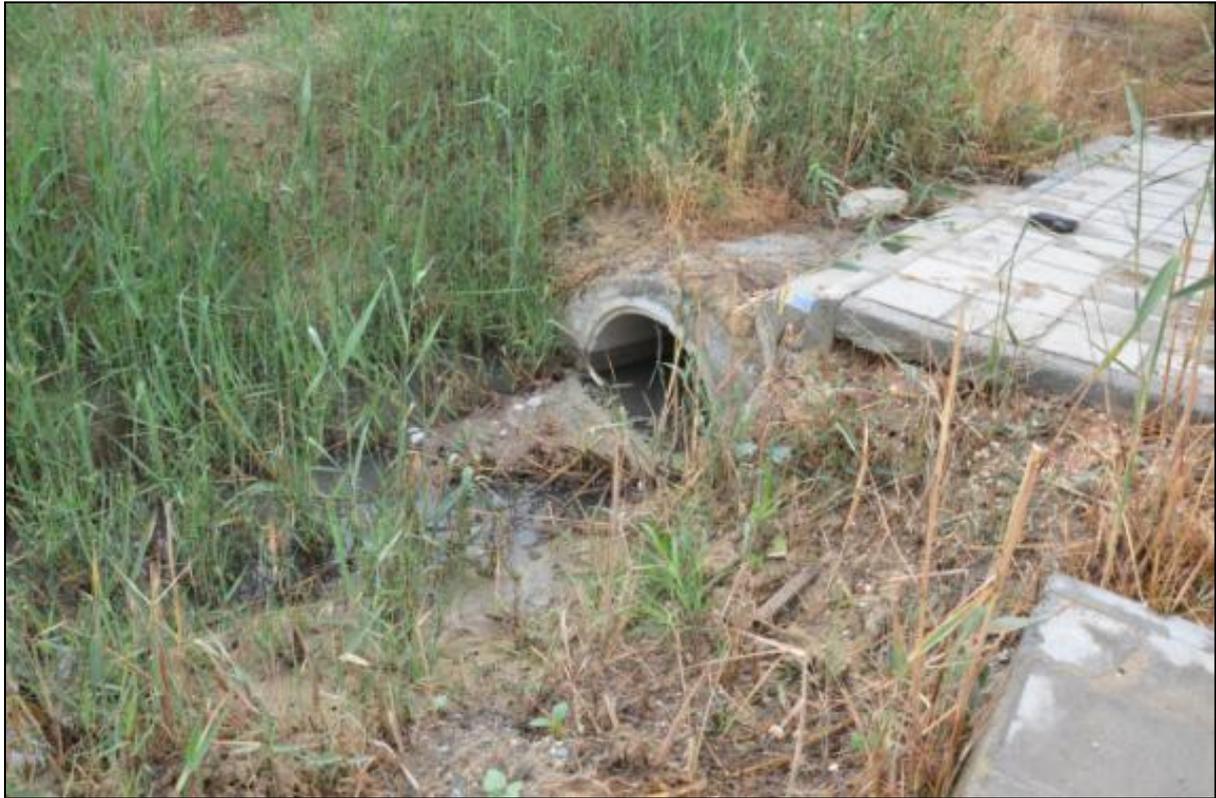
Photo 2-3, taken on the same date as above, shows the 120 cm diameter outlet of the central part of the storm-water network of Oroklini Village (point 1 on Map 2-3).

Photo 2-3. Outlet (120 cm diameter) of the central part of the storm-water network of the Oroklini Village

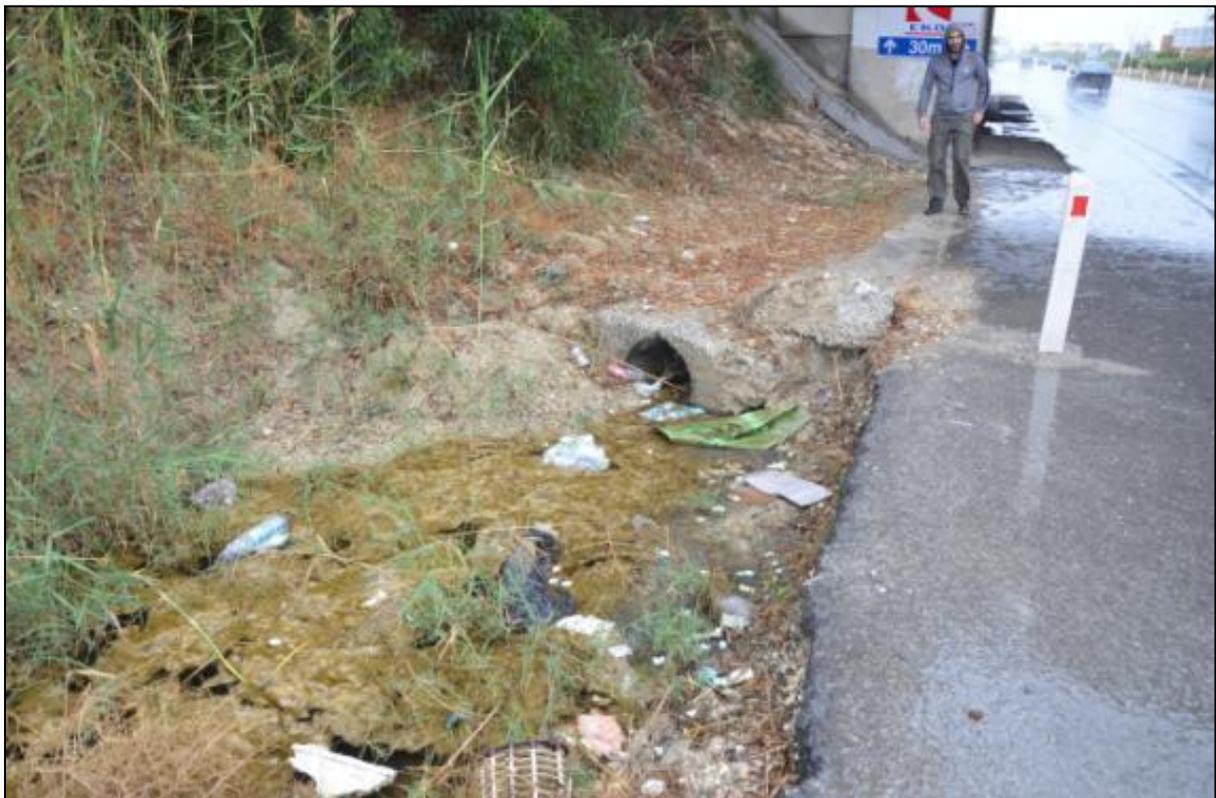
Photo 2-4. Entrance to the eastern part of the local drainage system in the area of the Lake which ends in the eastern part of the lake, next to the petrol station.

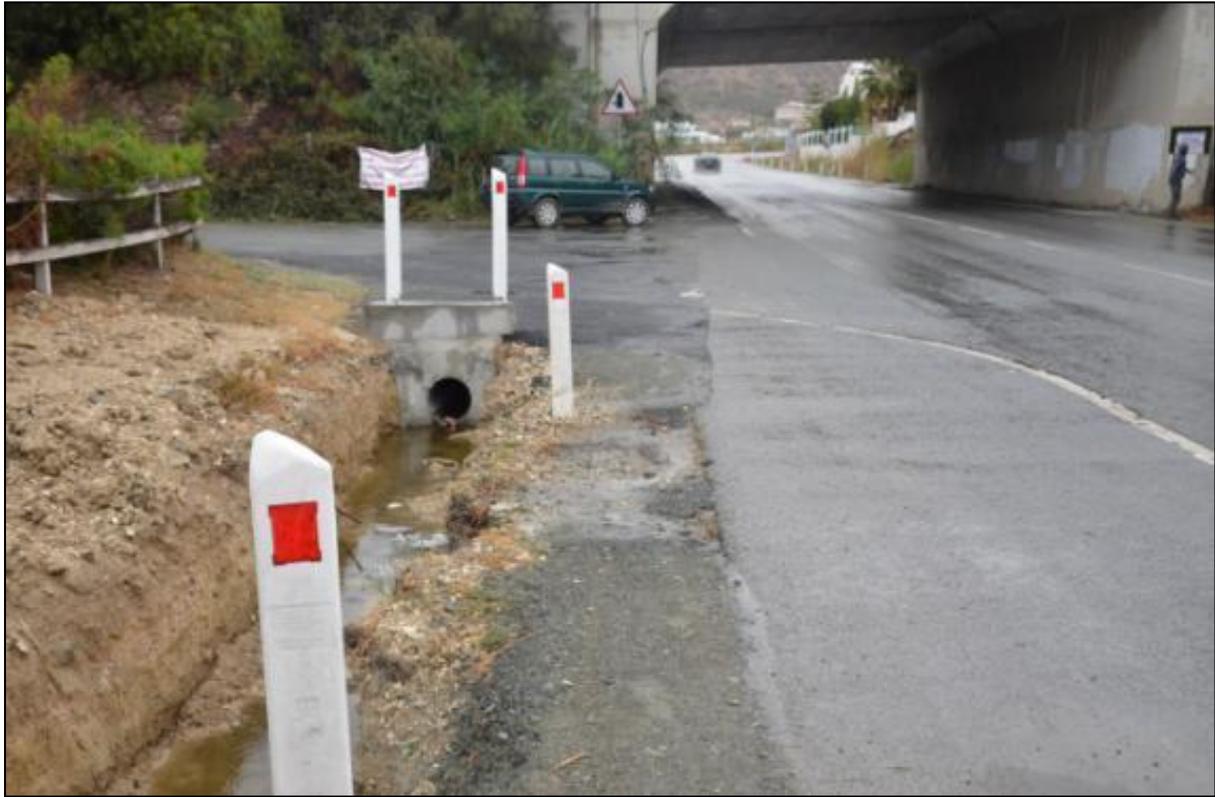
The Photo 2-5 shows the outlet of the storm-water sewer collecting the water from a small area upstream the Highway underpass and discharging it to the Lake (point 4 on Map 2-3).

Photo 2-5. Outlet of western part of local storm-water drainage at the Lake area

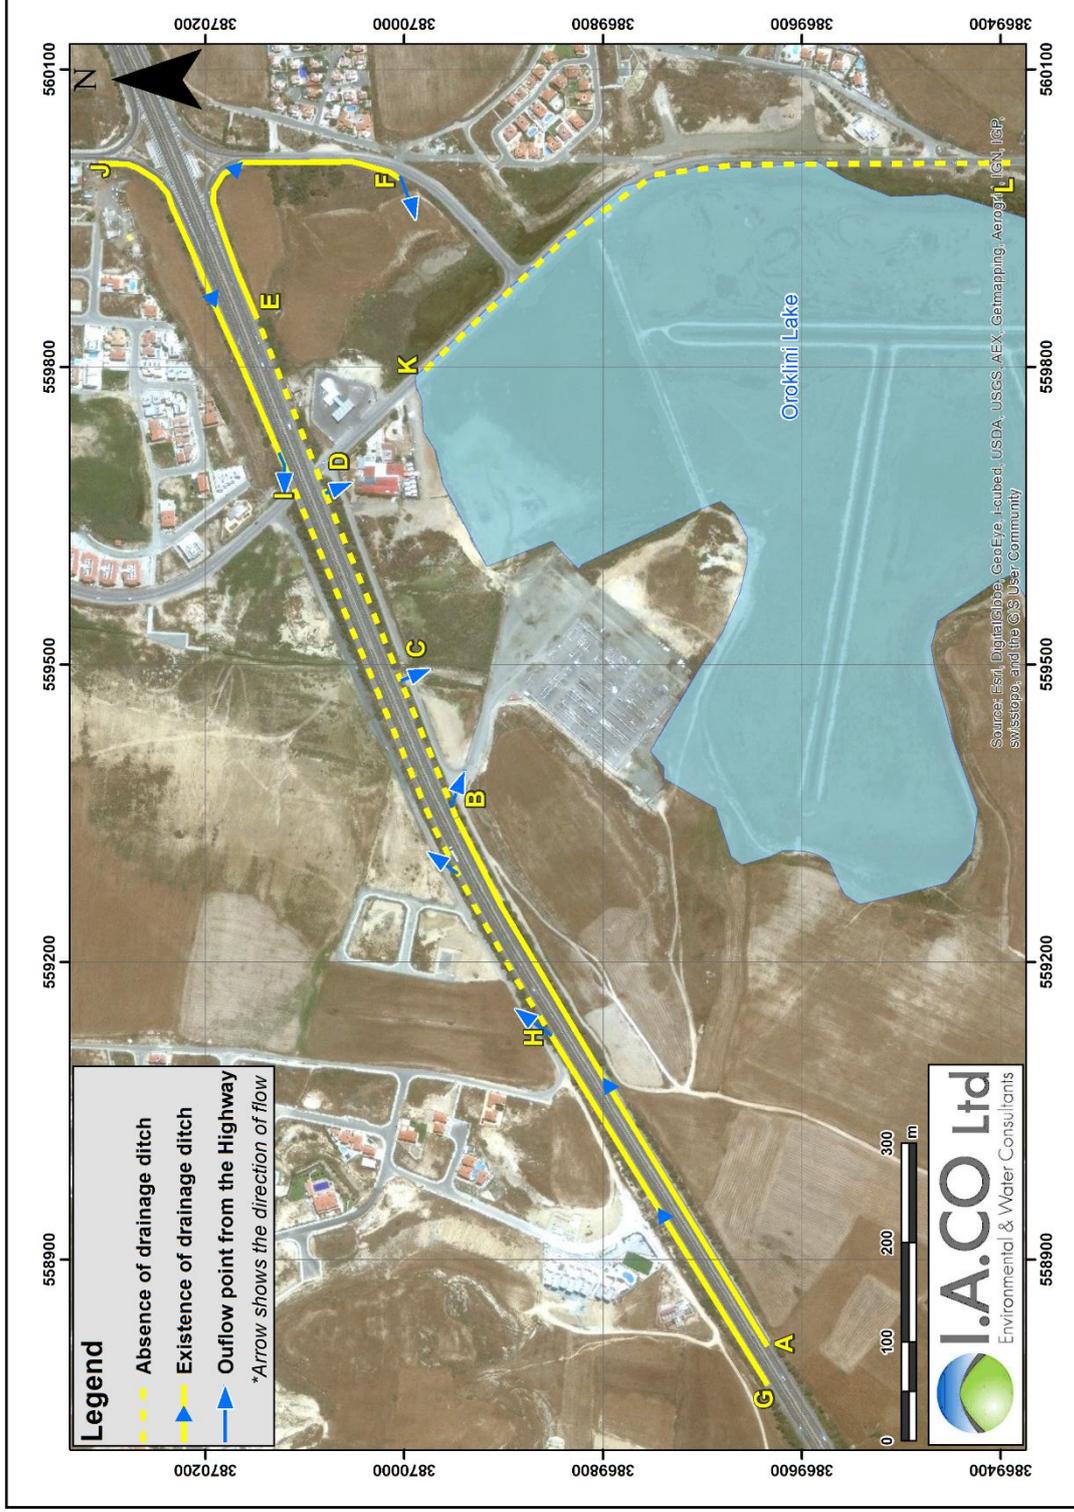
The storm-water runoff and potential accidental spill of petrol and other chemicals of the Paralimni – Larnaca Highway and of the road crossing the Lake connecting the coastal area to the Oroklini community is of some concern for the sensitive Oroklini Lake. The existing runoff management conditions at the highway and the road crossing the lake are as shown on Map 2-4 and Table 2-3.

Map 2-4. Storm runoff management conditions at the Highway and the road crossing the Lake

From the existing conditions at the highway and the road crossing the lake, it is apparent that no management plan to control the runoff away from the Lake exists. Rather, all the runoff finds its way to the lake. The same can be assumed that will happen in the event of an accident of, for example, a truck carrying petrol or any other chemical or of a bowser carrying wastewater.

Obviously, a management plan needs to be established to correct the situation for the Highway and the road crossing the Lake. Some suggestions /recommendations towards this direction are provided later in the text.

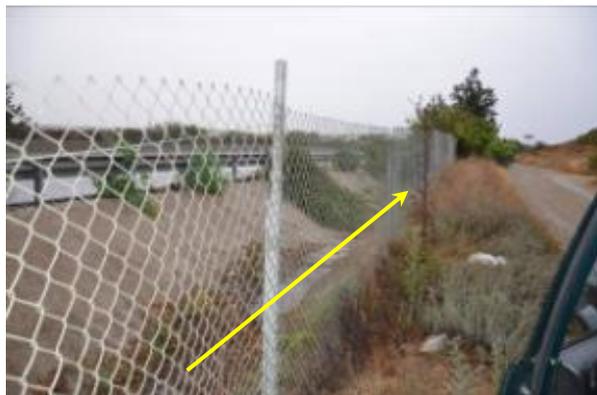
Photo 2-6: Points A to B: Runoff through a concrete and an earth ditch

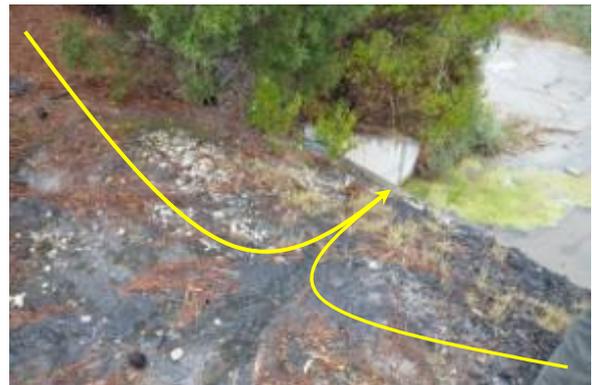
Photo 2-7: Points B to C and from D to C: Runoff discharging to a point above Box Culvert without ditch

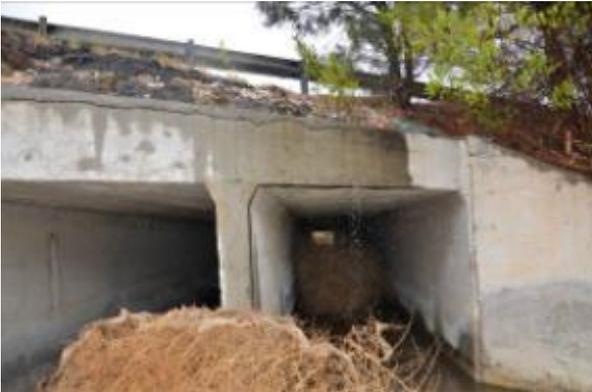
Photo 2-8: Runoff from Highway between points B to C and from D to C flowing over culvert and to the Lake

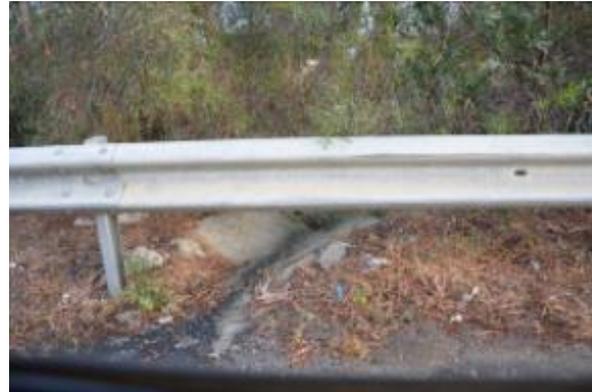
Photo 2-9: Points E to D: Runoff discharging to point D through a small V-notch

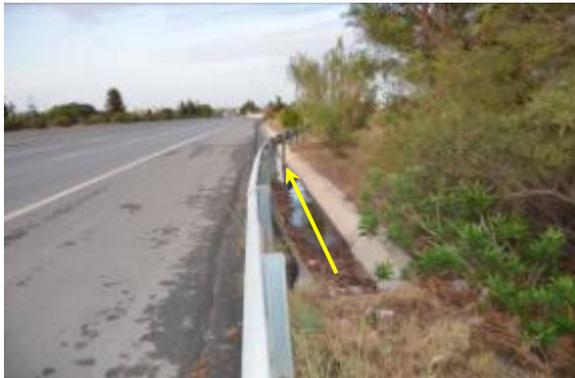
Photo 2-10: Points E to F: Flow through concrete ditch (for half distance) and discharge to the eastern part of the lake

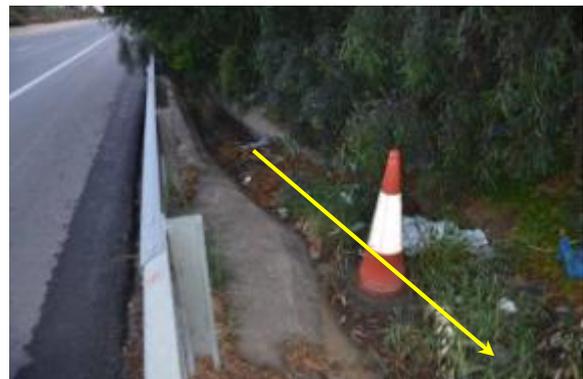
Photo 2-11: Points G to H: Runoff through a concrete ditch and discharge to the adjacent service road

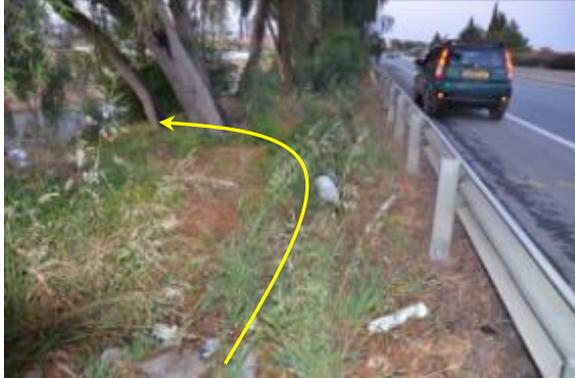
Photo 2-12: Points G to H: Runoff through a concrete ditch and discharge to the adjacent service road

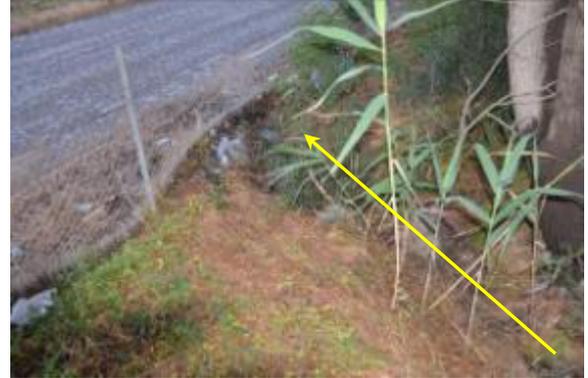
Photo 2-13: Points G to H: Runoff through a concrete ditch and discharge to the adjacent service road

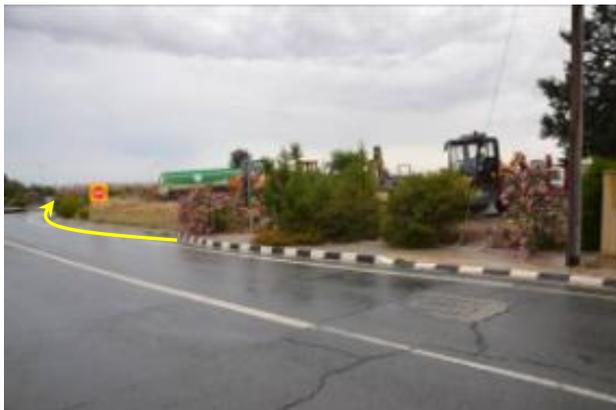
Photo 2-14: Point J to I: Concrete ditch starting from side-road entering Highway at "Scrap and petrol products storage area"

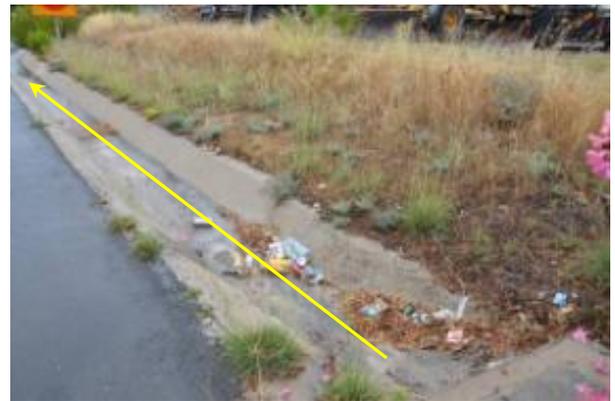
Photo 2-15: Zoom -in of area shown by Photo 2-14

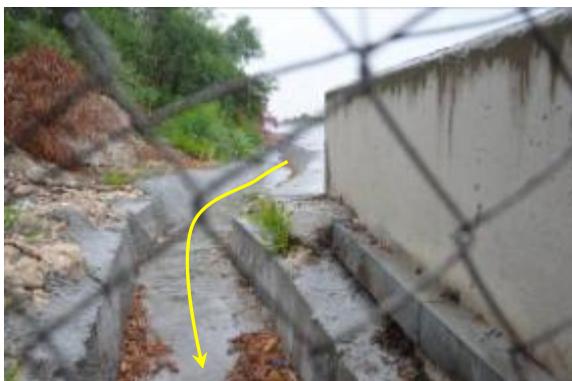
Photo 2-16: Point J to I: Concrete ditch off side of highway before entering cascade steps and entering the storm-water sewer

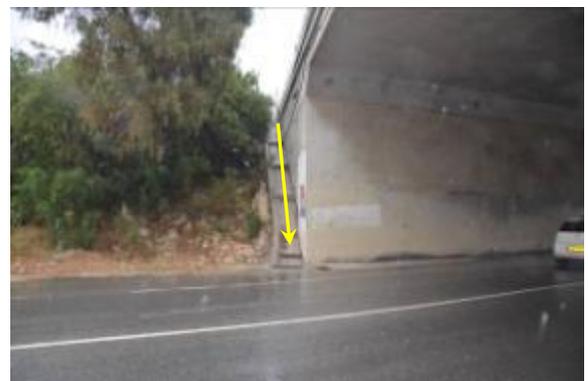
Photo 2-17: Cascade steps for runoff flow into storm-water sewer shown on Photo 2-4

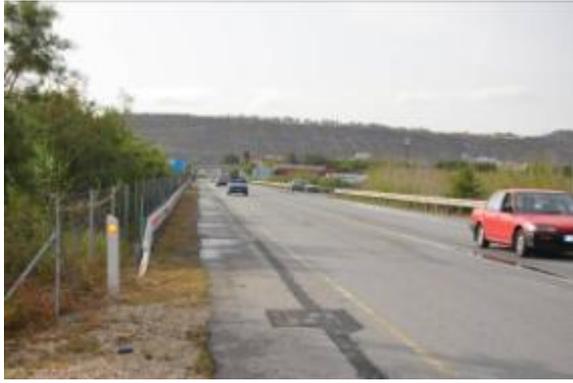
Photo 2-18: Points K to L: The road connecting the coast to Oroklini and crossing the Lake (looking north). Runoff flows to the Lake on either side

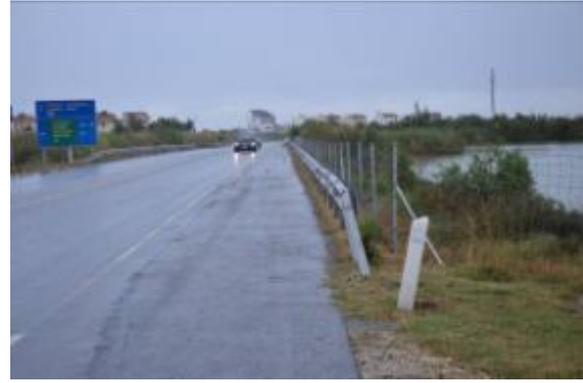
Photo 2-19: Points K to L: The road connecting the coast and Oroklini and crossing the Lake shown to the right (looking south). Runoff flows to the Lake on either side

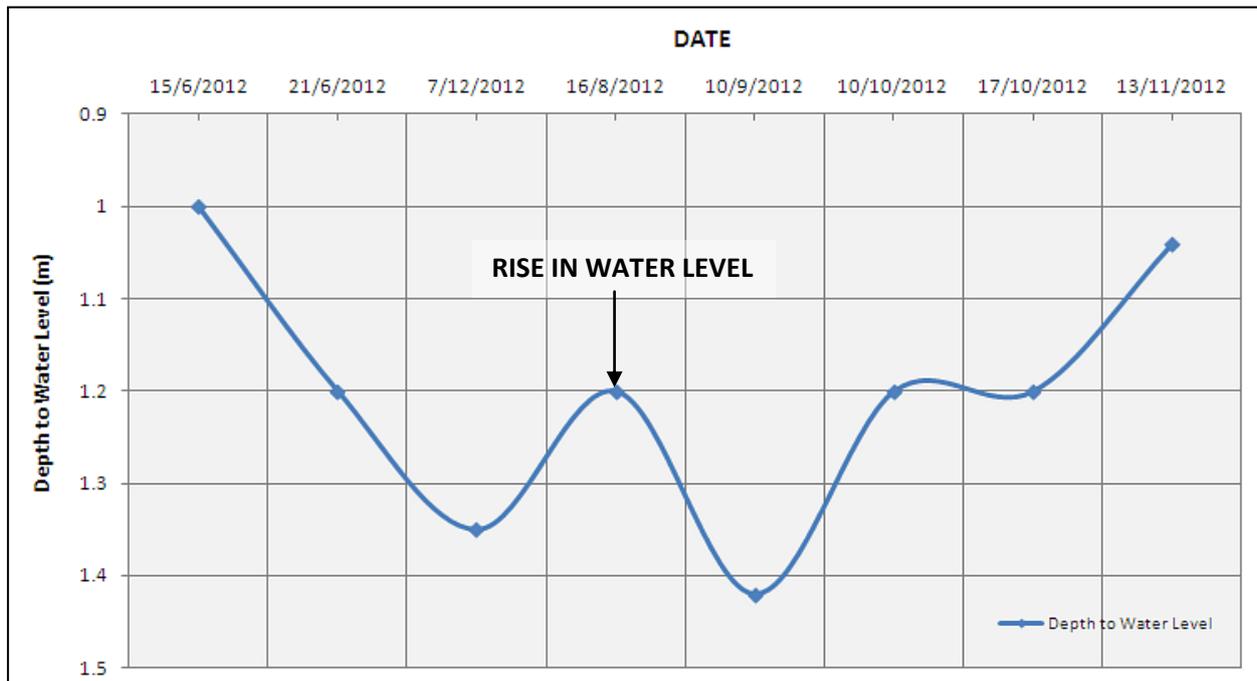
Figure 2-1: Groundwater level observations showing a rise during the touristic month of August which can only be attributed to increased return of wastewater to the underground since rainfall was nil.

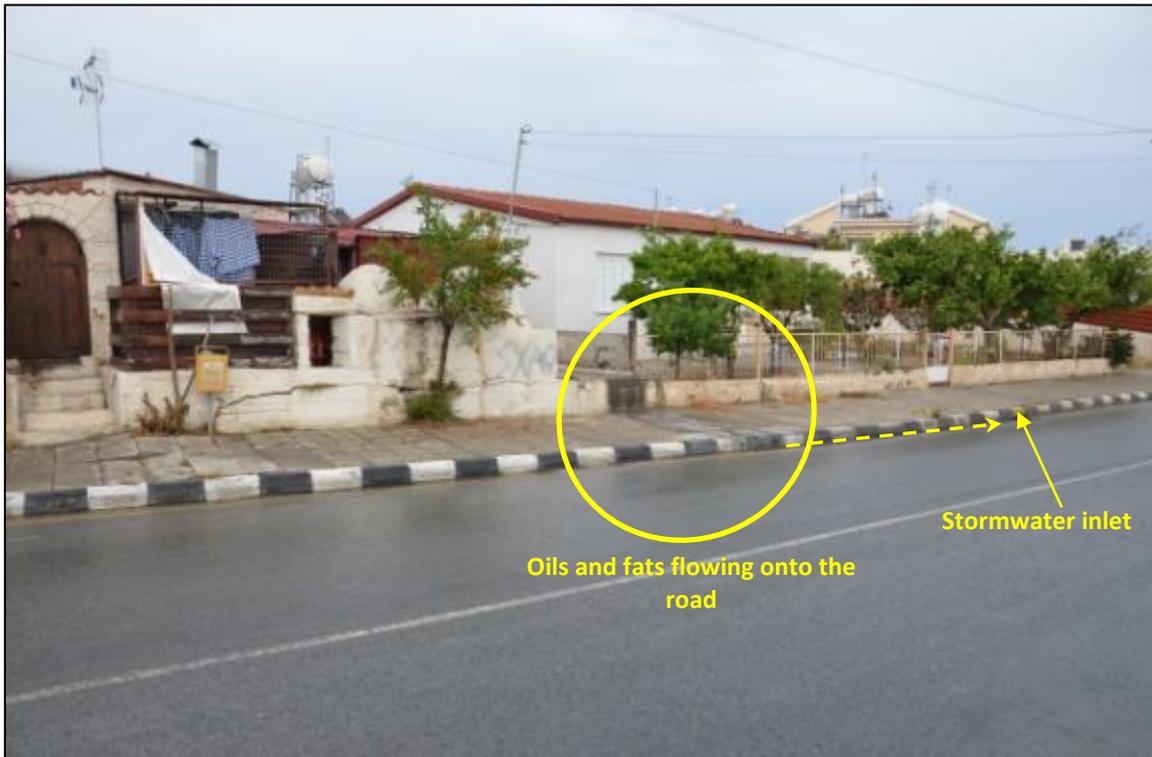
Photo 3-1 shows an example of poor waste vegetable oil management in a case outside one of the seven restaurants (Photo 3-1).

Photo 3-1. Waste vegetable oils and greases from a restaurant disposed to a street and collected by storm water network

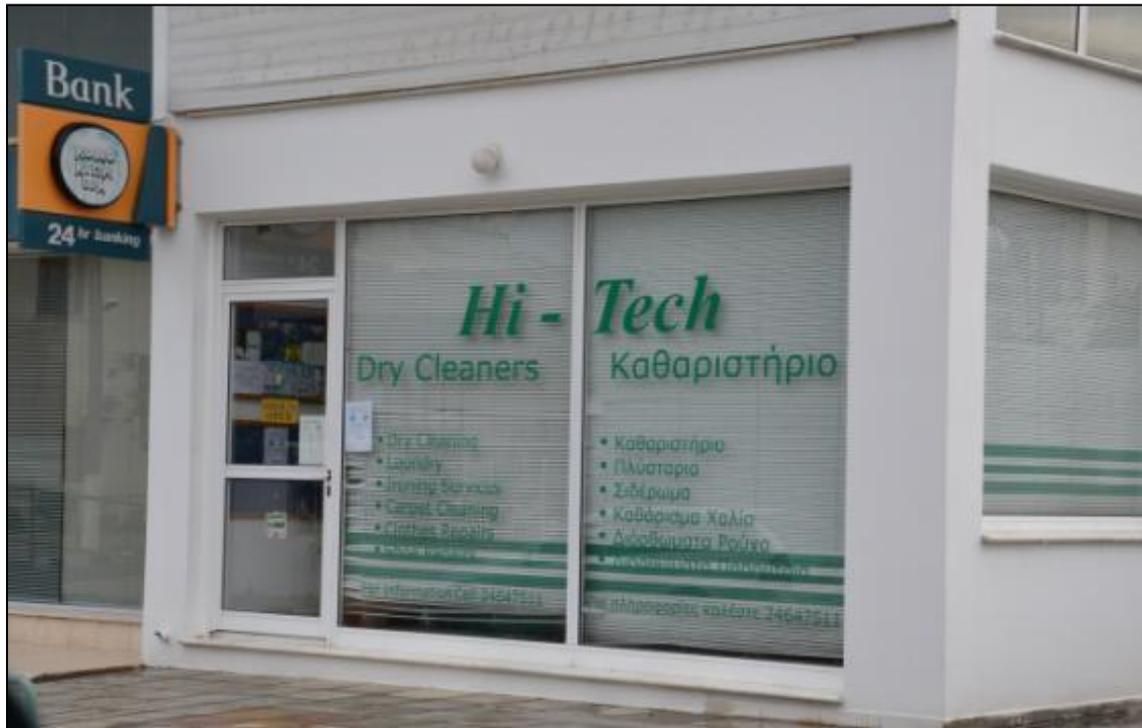
The dry cleaning store shown in Photo 3-2 is equipped with modern dry cleaning machines that use a closed-loop system. This means high solvent recovery rates and reduced air pollution. The solvent used in the process is PERC (tetrachloroethylene). PERC is one out of the 45 priority substances listed in Directive 2013/39/EU⁴.

Photo 3-2. Dry cleaner in Oroklini's community main road

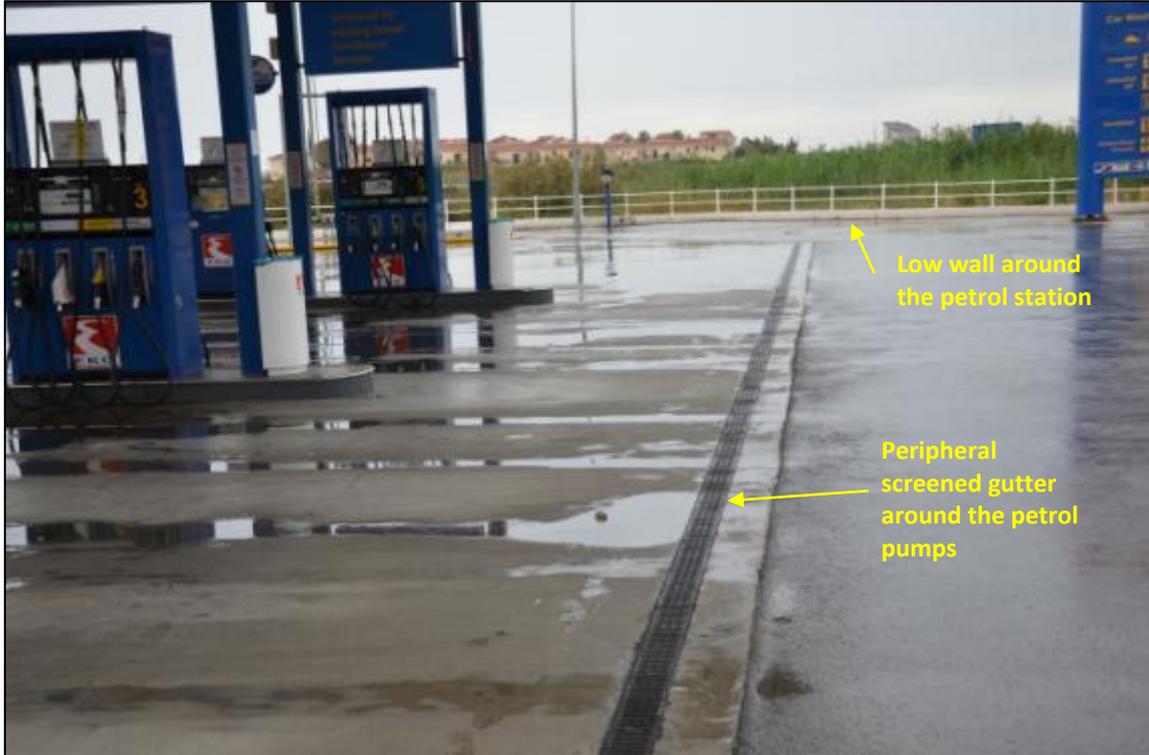
Of particular concern to the sensitive area of the Oroklini Lake has been the presence of the petrol station only a few meters away from the Lake as shown on Map 3-1. Observing the present conditions regarding the disposal of runoff both of storm water as well as of any other chemical, oils and petrol, it appears that a number of measures have been taken to safeguard the disposal of any of these to the Lake.

Photo 3-3. The Petrol Station 10-20m away from the Oroklini Lake

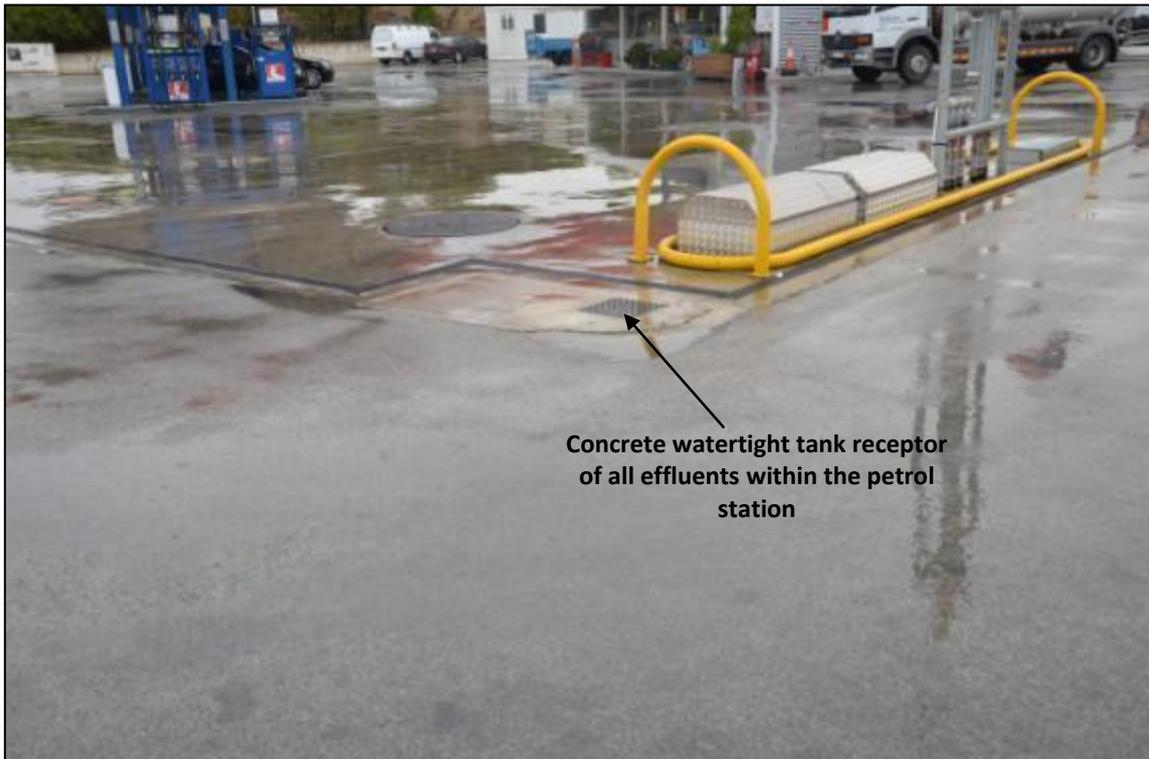
Concrete watertight tank receptor
of all effluents within the petrol
station

Photo 3-4. Concrete watertight tank properly emptied occasionally

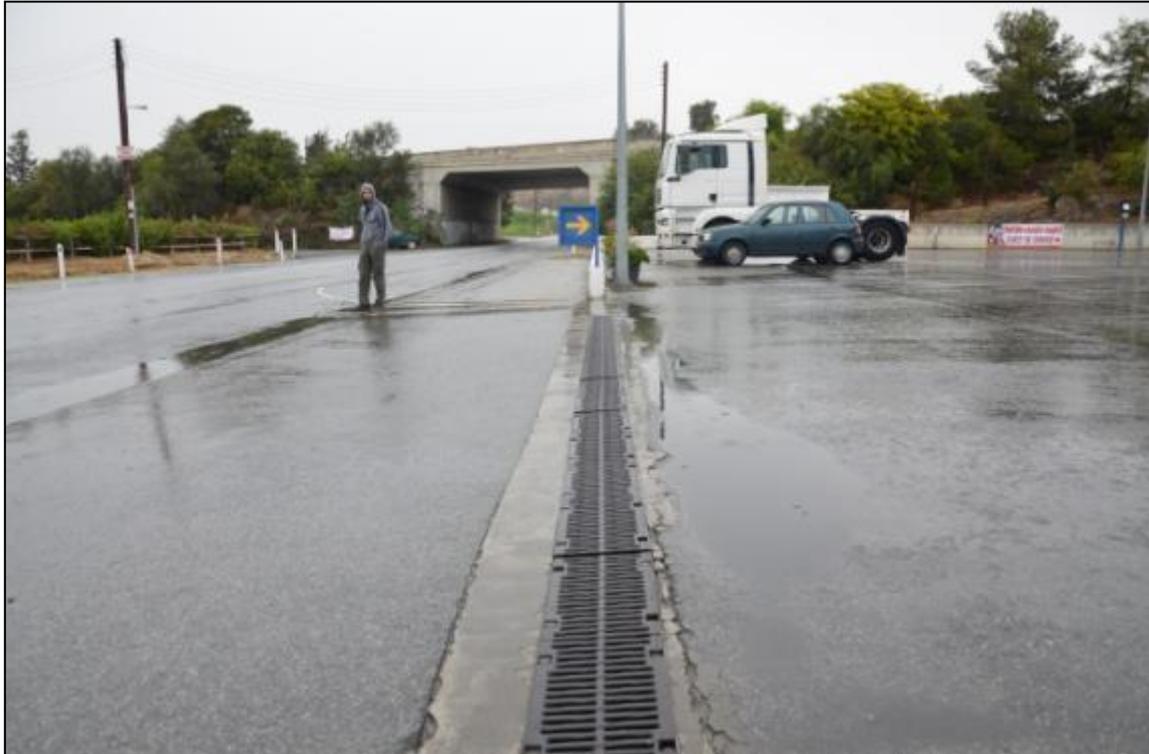
Photo 3-5. Screened gutter at the entrance of the Station collecting all effluents from the Station and discharging them into the watertight tank

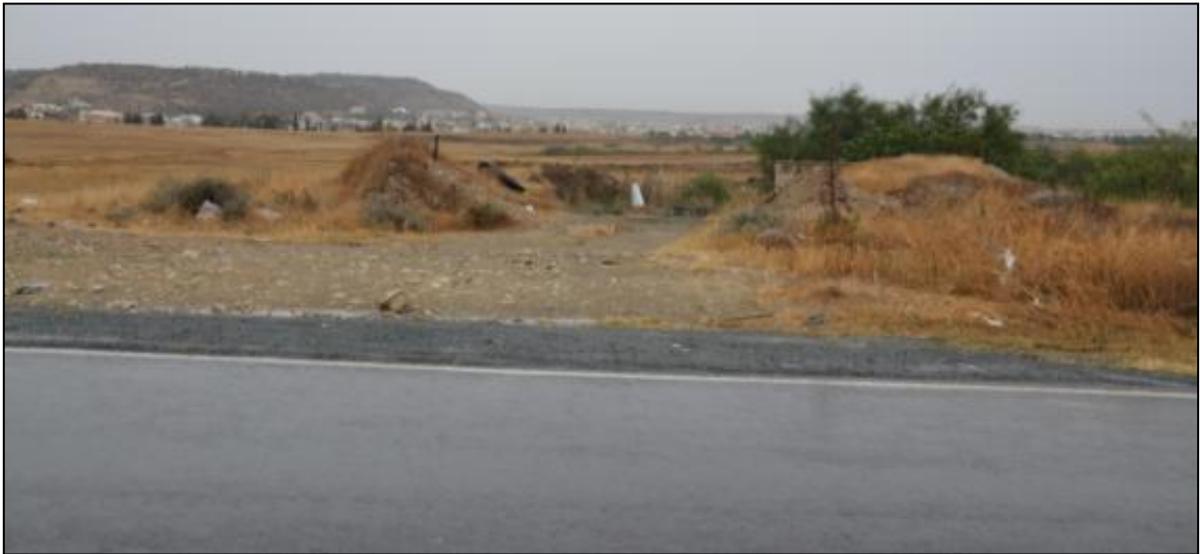
During a site visit at the catchment area on the 6th of May, an uncontrolled dump site was detected on the south-western part of the catchment area of the Lake as shown on Map 3-1. Photos 3-6 to 3-9 show the extent of various types of wastes dumped at this site. Excess storm-water which becomes runoff flows directly into the lake as there is no control or management for it. On the basis of a research of satellite photographs (Google Earth) this site seems to be active since and before 2003.

Photo 3-6. Entrance to the uncontrolled dump site

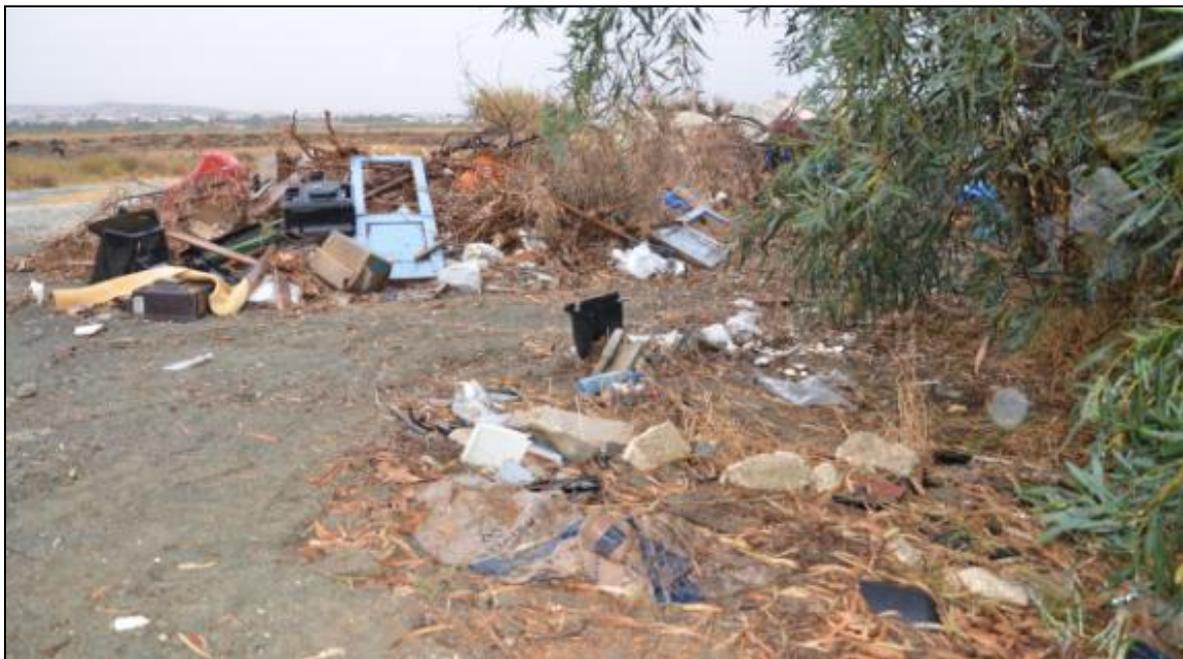
Photo 3-7. Inert and electronic equipment wastes at the uncontrolled dump site

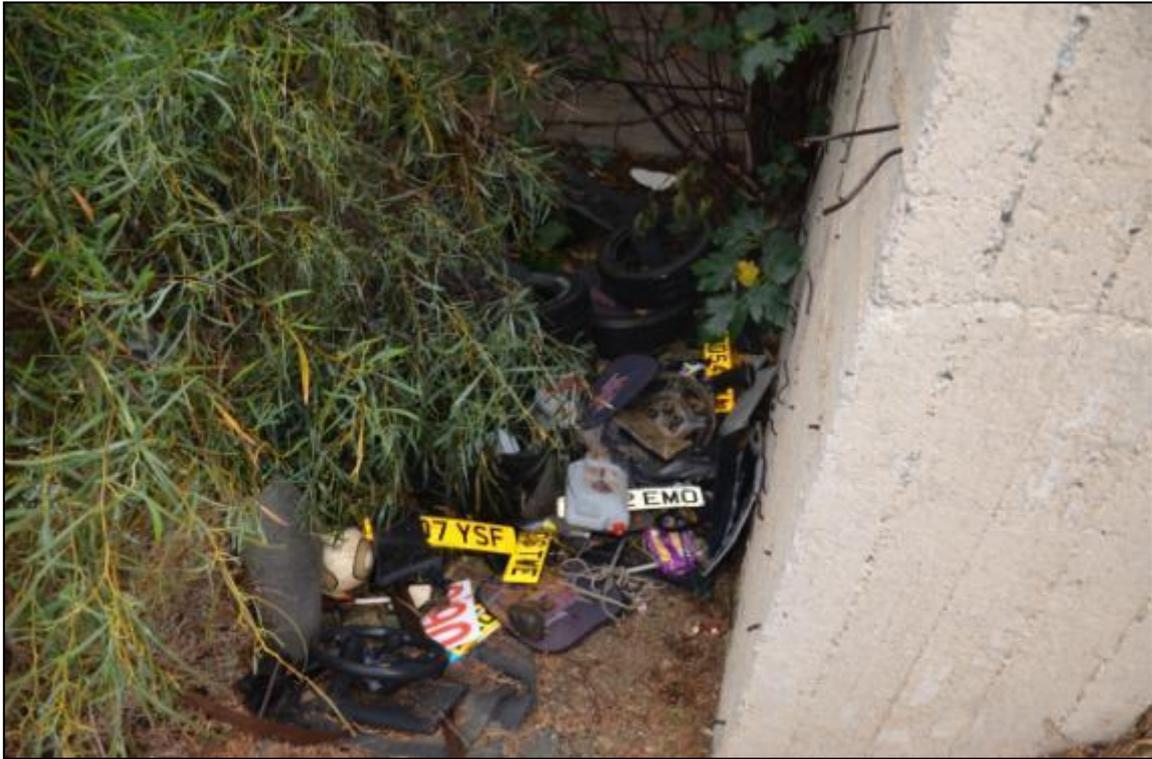
Photo 3-8. Tire wastes at the uncontrolled dump site

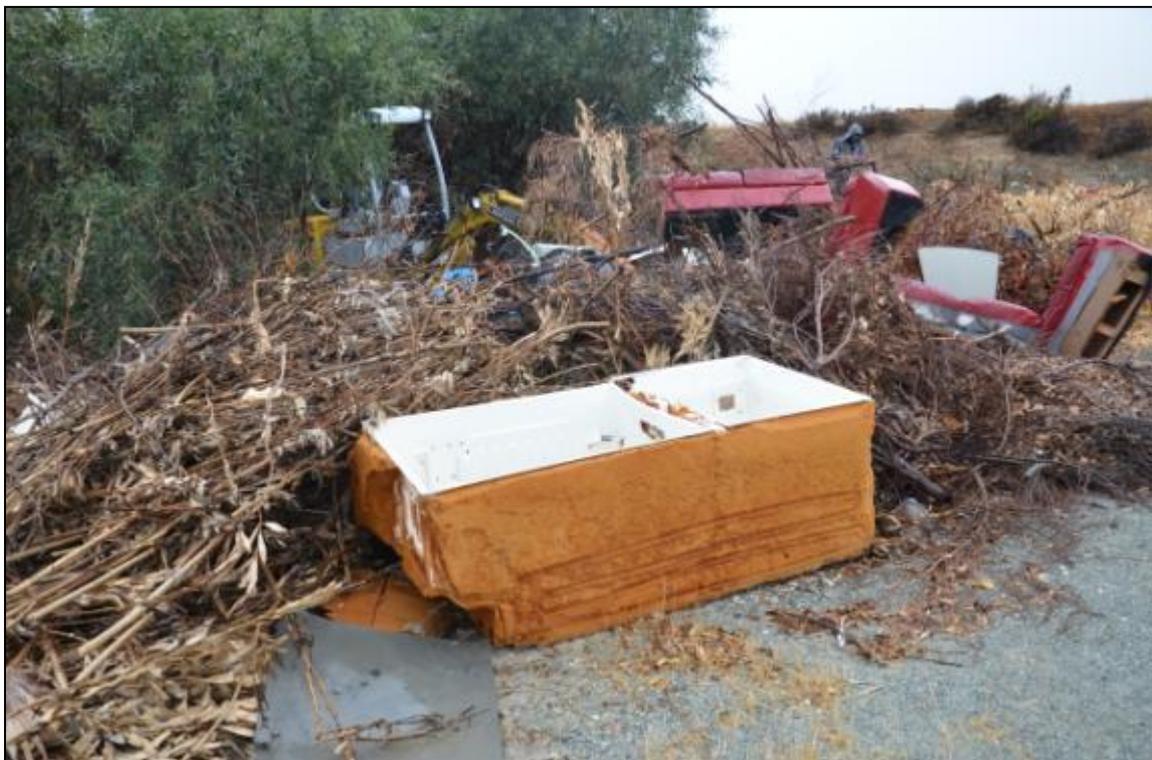
Photo 3-9. Inert wastes and pruning wastes at the uncontrolled dump site

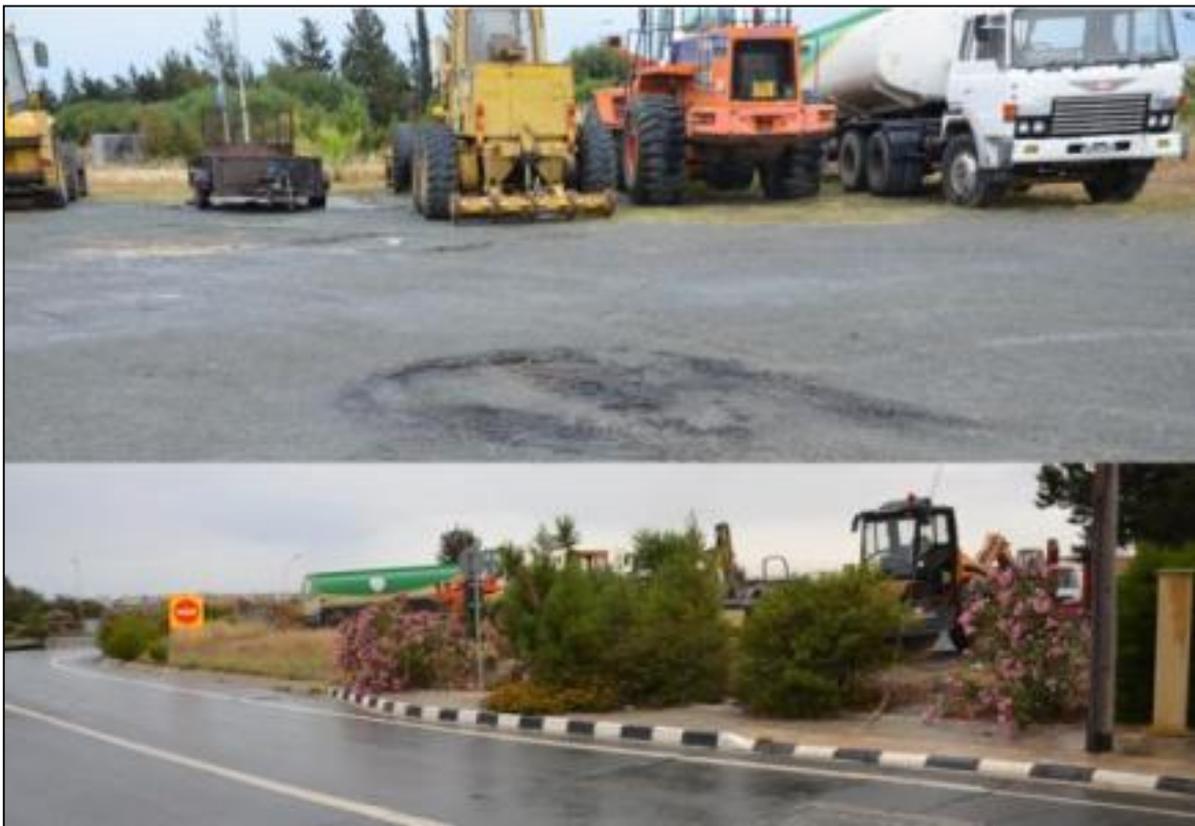
On Map 3-1 a site of uncontrolled storage of petroleum products and scrap metals is shown on the south-eastern fringe of the water-divide of the catchment just north of the Highway. Photo 3-10 shows a view of the storage site from which the storm-water runoff ditch begins, enters the highway and ends up in the Lake as discussed in detail in paragraph 2.2.4 under “Highway drainage present conditions”.

The present day conditions of the storage site are presented in the Photos 3-10 to 3-15 shown below. No storm – water runoff management arrangement has been noticed except the discharge to a ditch next to the entrance road to the highway that eventually ends up to the Lake. The same holds for any oils, greases and other petrol products that find themselves disposed within the yard.

Photo 3-10: View of the uncontrolled petroleum products storage site from the highway exit (below) and view of the vehicles from within the plot
