JUNE 2014

Analysis of Pressures and Impacts on runoff water quality for the Oroklini Lake catchment

Specific task as part of the project LIFE10 NAT/CY/716 where BirdLife Cyprus is an associated beneficiary

Final Report

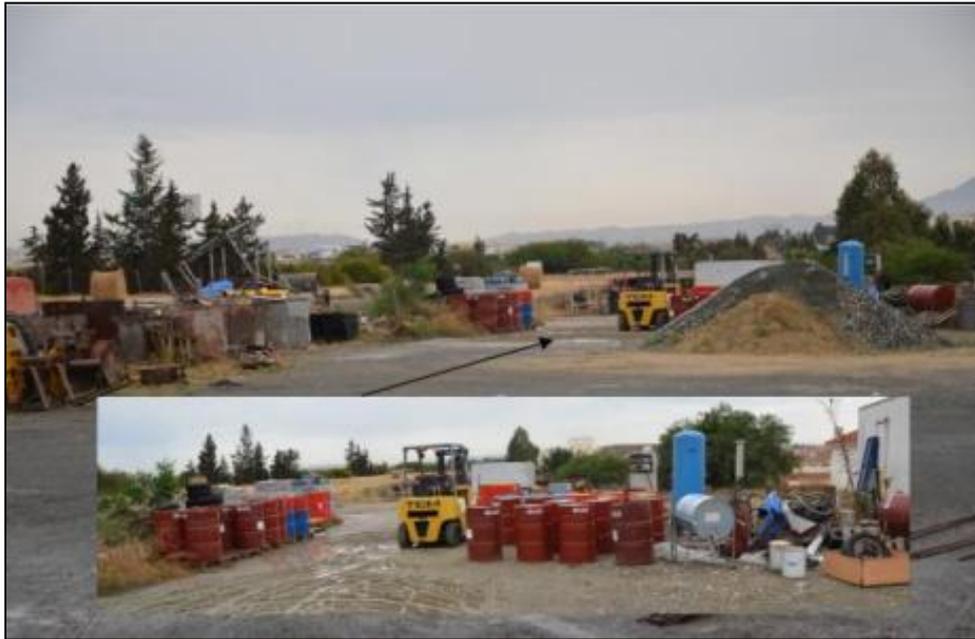
This storage area of scrap metals and petroleum and other products presents a threat to the sensitive environment of the Lake especially since the full type of products stored in the area are not known and runoff, as explained, finds itself flowing to the Lake.

Photo 3-11: View of the uncontrolled scrap metals and petroleum products storage site from within

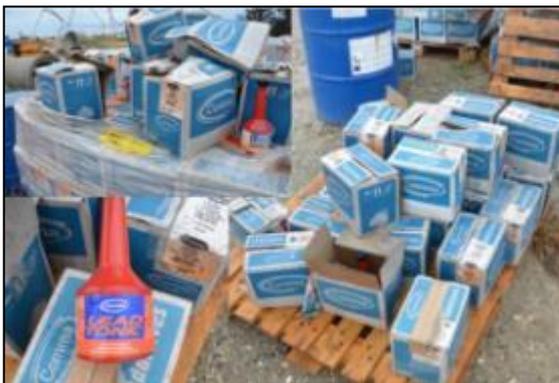
Photo 3-12: Lead additive products (for old engines designed to run on leaded petrol)

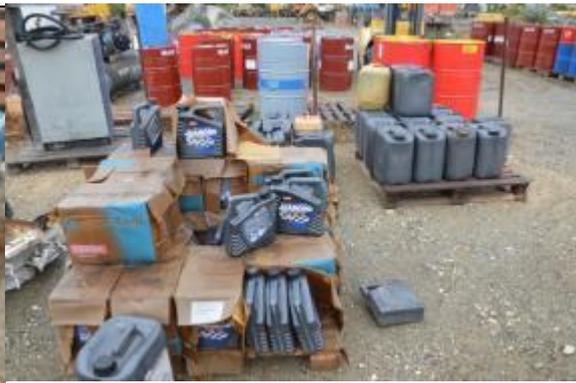
Photo 3-13: Engine oil products within the site

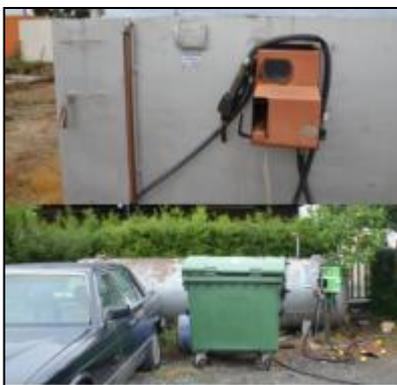
Photo 3-14: Two photos showing tanks for fuel supply

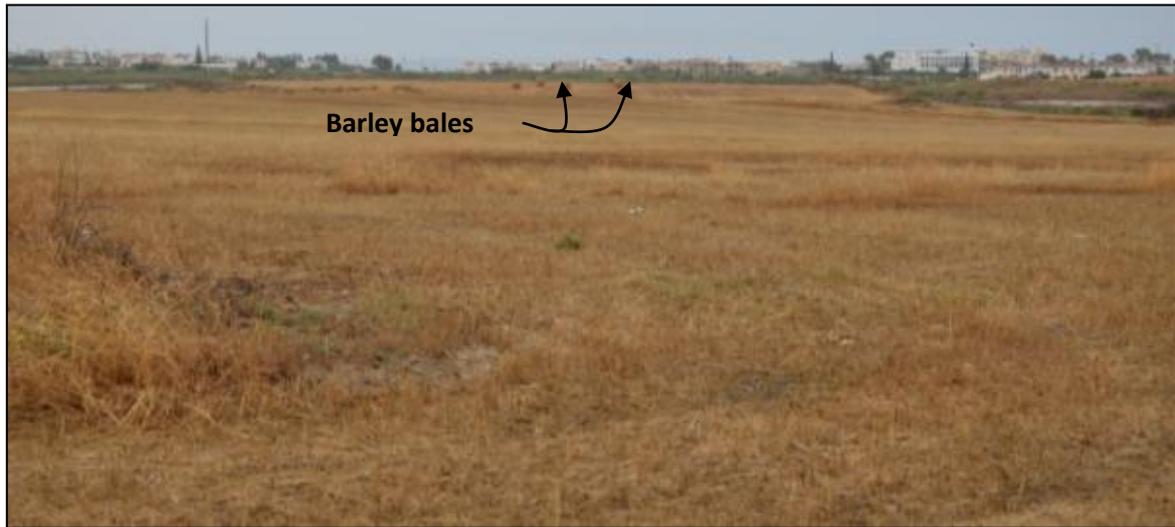
In the following photograph a sample of the crops' area is presented, particularly on the west side of the lake. On the back of the landscape shown in Photo 3-16, the barley bales can be distinguished.

Photo 3-16. Barley crops on the western part of the lake

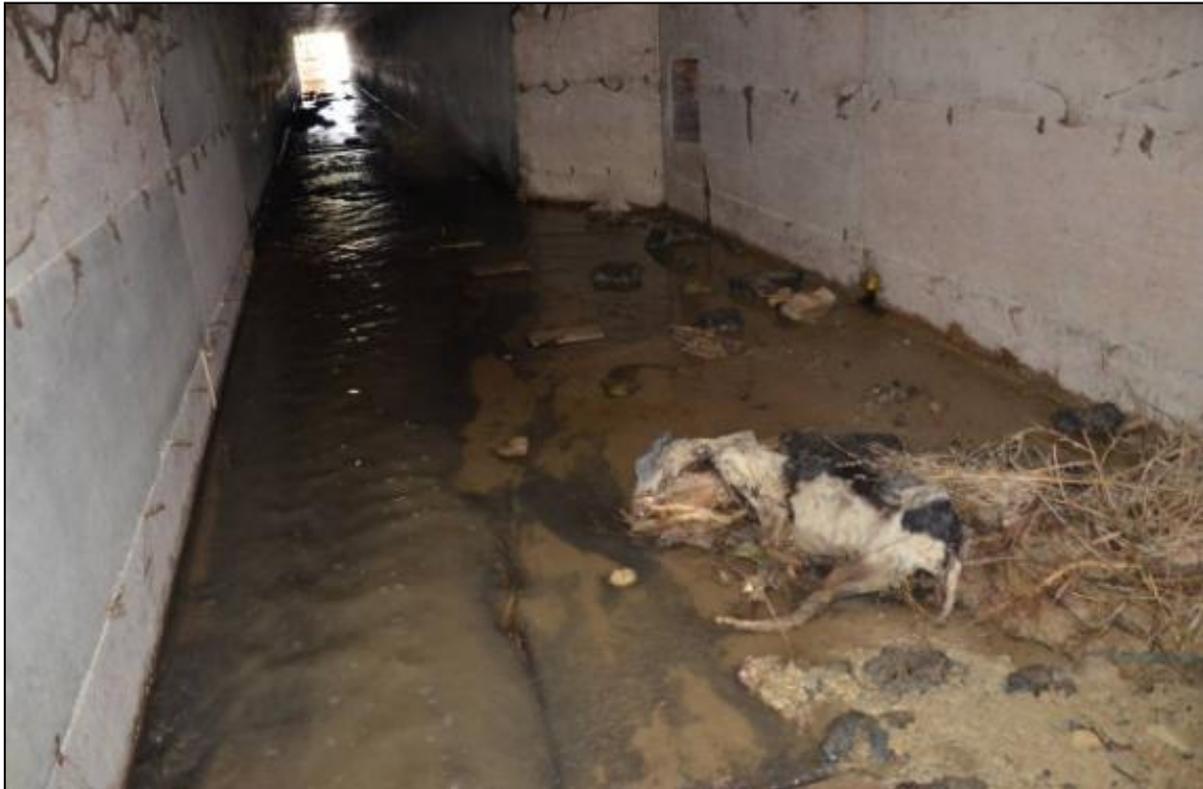
Photo 3-17: A carcass in the culvert under the highway which discharges to the lake

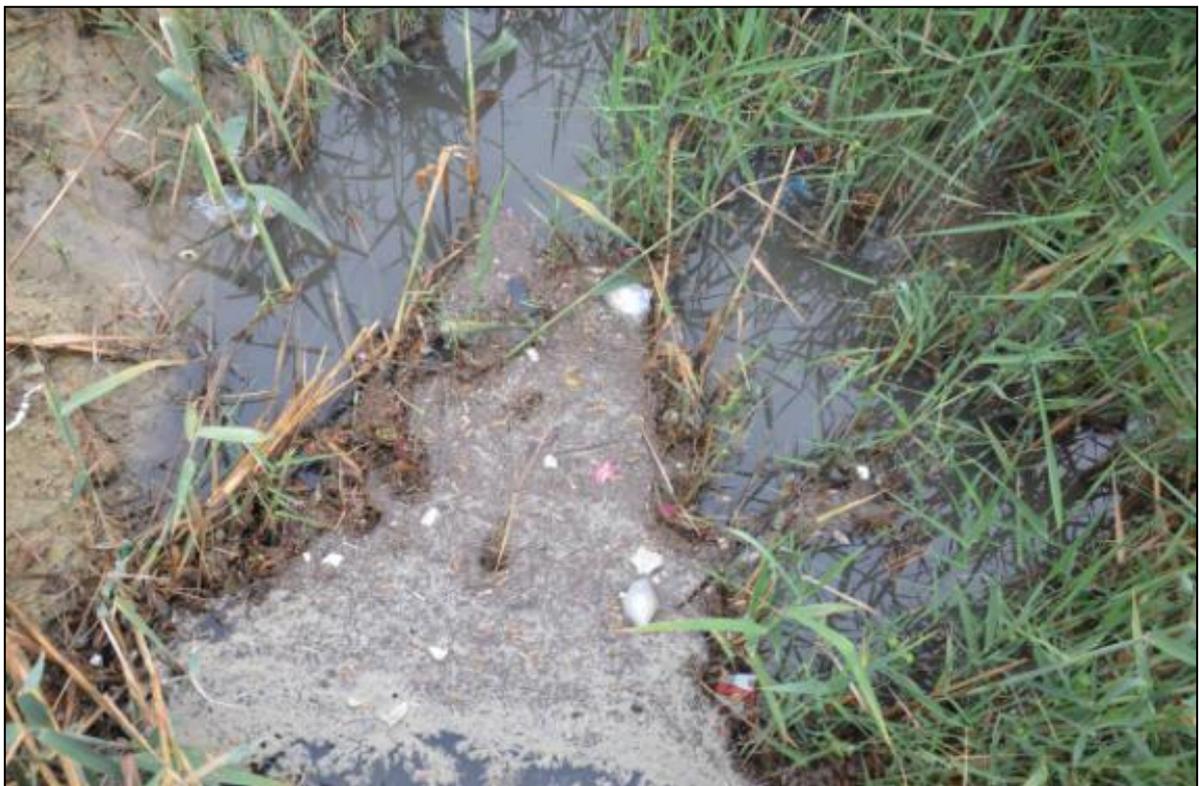
Photo 3-18: Discharge with debris at the outlet of the central storm - water network. The role of the reeds in controlling pollutants is clear

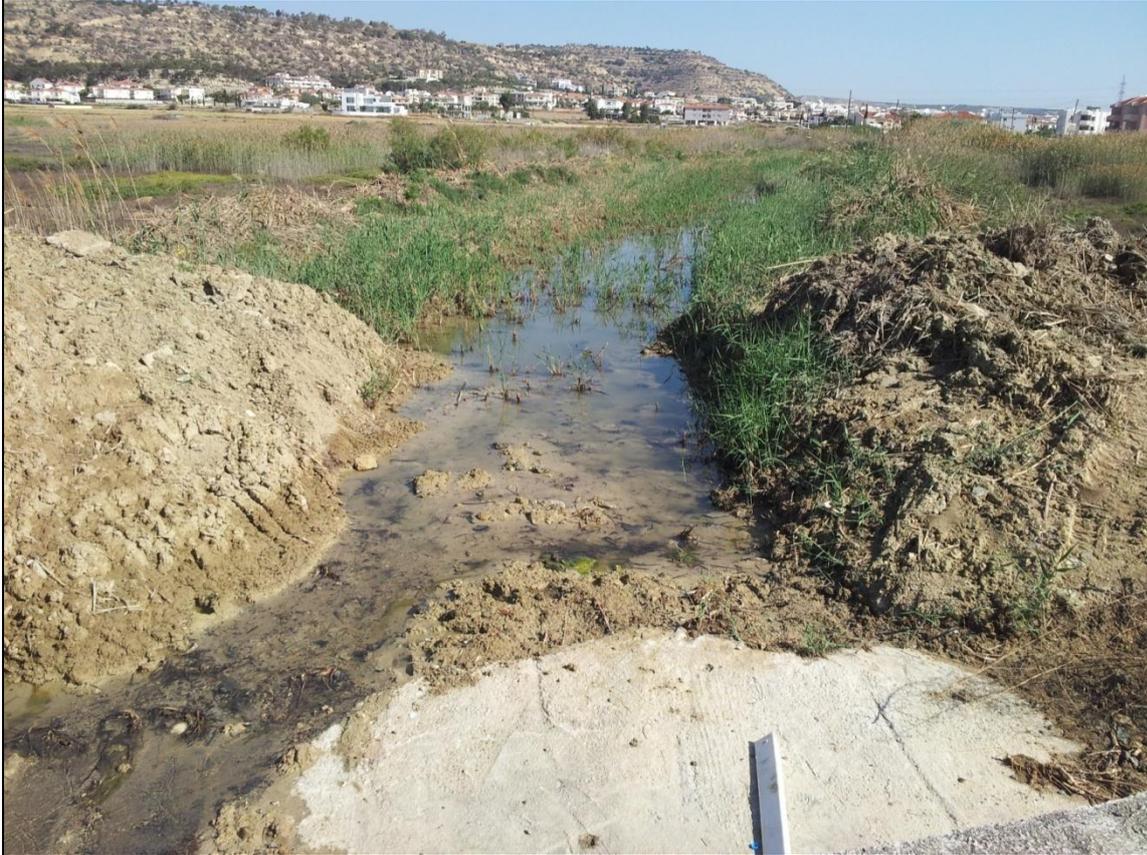
Photo 3-19: Overview of the stream feeding the Oroklini Lake, after clearing works and the removal of large quantities of *Phragmites australis* biomass, upstream the highway. The regeneration of reed shoots is already taking place

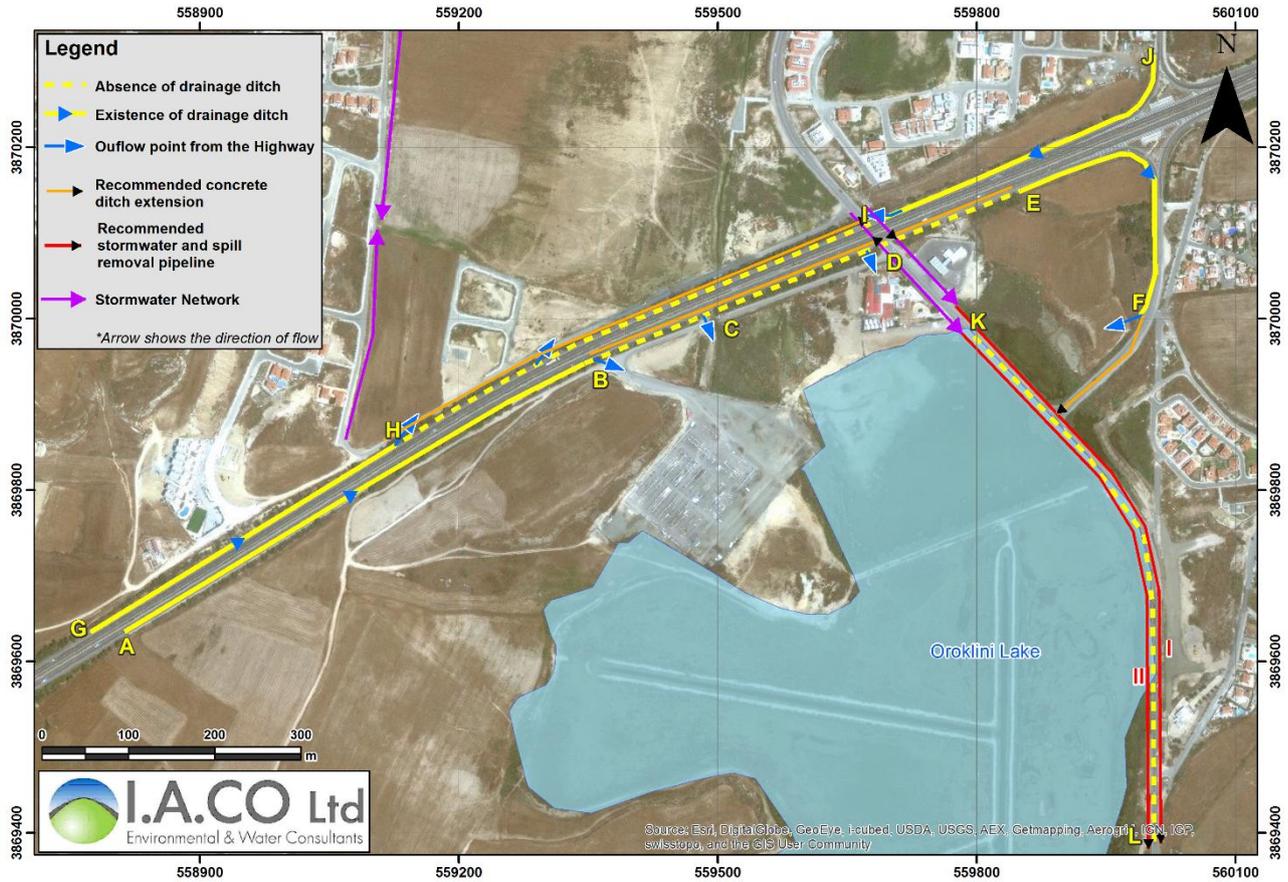
Map 4-1: Map showing recommended works for managing storm-runoff and accidental spills from entering the Lake

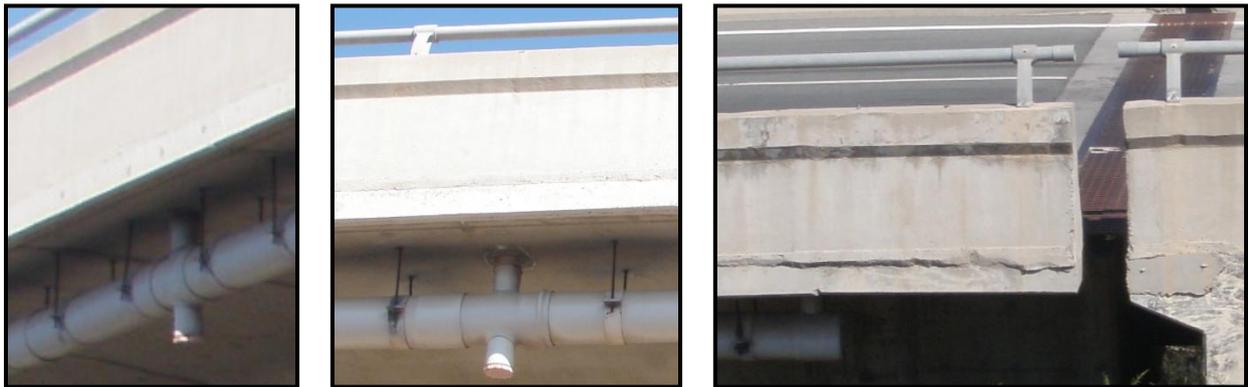
Photo 4-1: Views of a pipeline collecting storm-water and spills from the Limassol – Paphos highway at a point over Symvoulos Reservoir and suggested for the public road crossing the Lake
