ACTION PLAN FOR OROKLINI LAKE, CYPRUS

Hannah Morton, Site Manager, RSPB
& Melpo Apostolidou, Project Co-ordinator, BirdLife Cyprus

September 2014

This Action Plan has been produced as part of the project “Restoration and Management of Oroklini Lake SPA (CY6000010) in Larnaca, Cyprus” which is co-funded by the LIFE financial instrument of the European Union

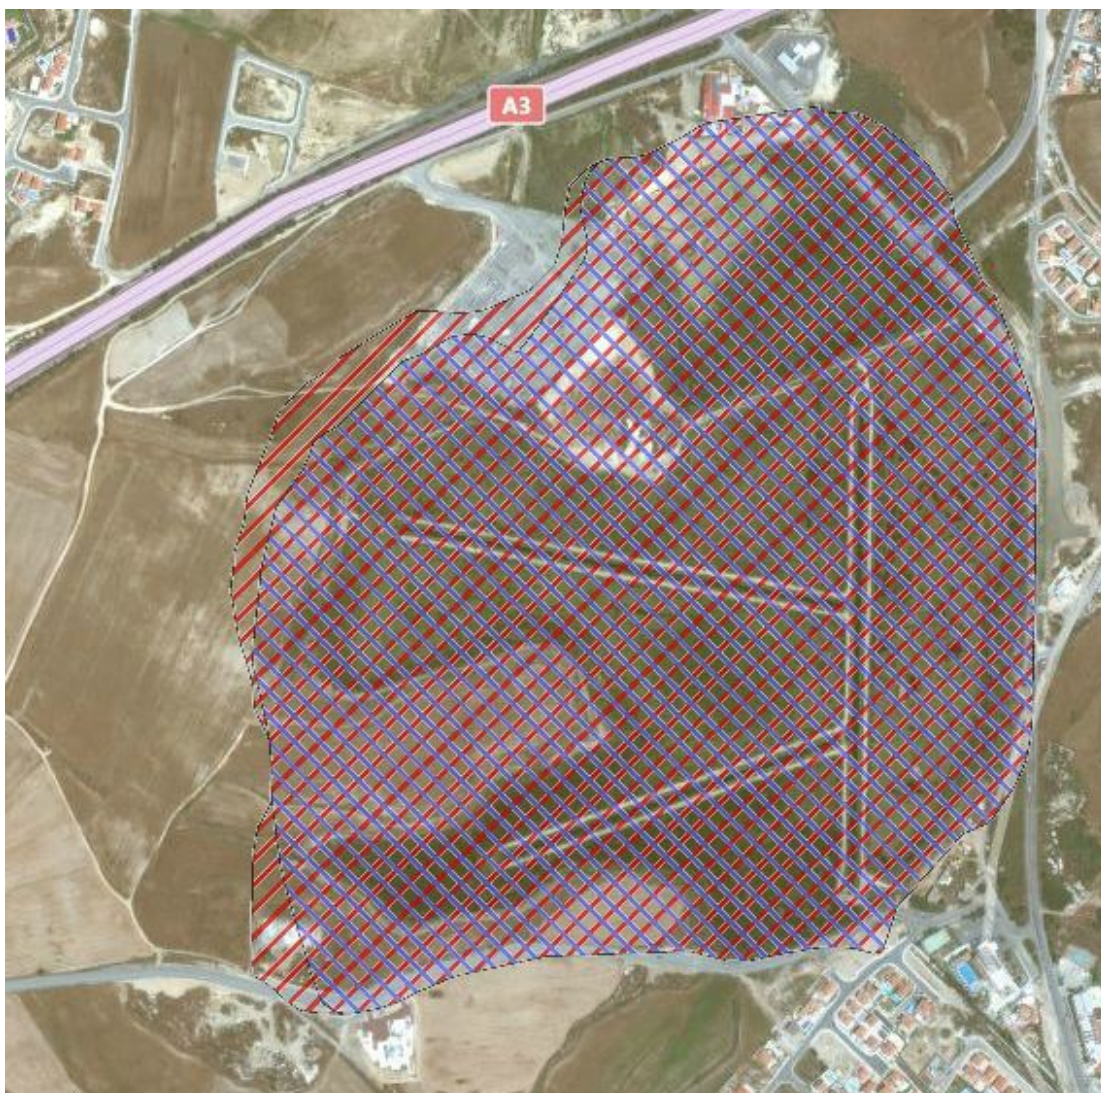
Figure 2. The areas included within the Special Protection Area (red) and Site of Community Importance (blue) at Oroklini Lake.

The extent of the SCI, 53ha, is shown on Figure 2 in blue. These halophytic communities, which have a restricted distribution and low coverage on Cyprus, consist of three types of Annex I Habitat types whereas in Oroklini wetland includes the rare species *Suaeda aegyptiaca* which is only found in salt marshes and margins of salt lakes within the Larnaca-Oroklini area and is therefore of importance in the context of the island.

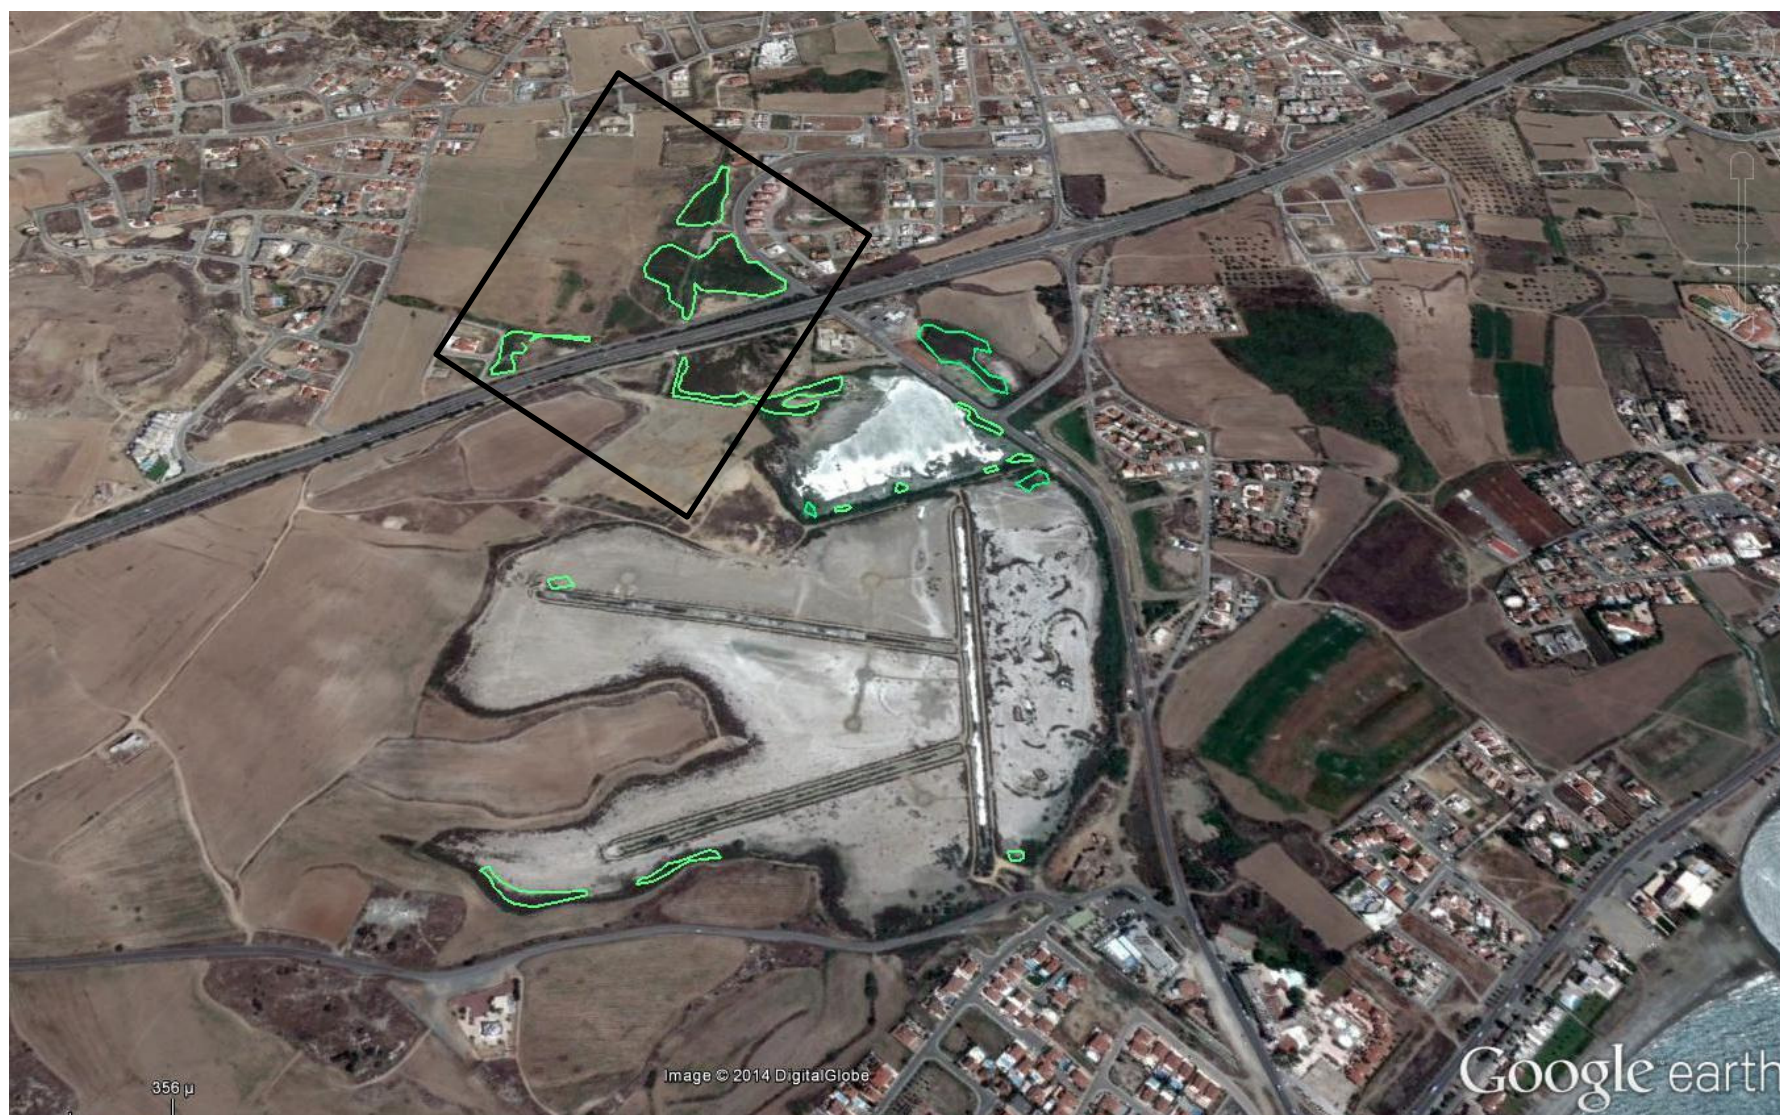
Figure 4: Map showing current extent of reeds (*Phragmites australis*), Oroklini Lake 2014.

- Water levels allowed to naturally increase from September and maintained through winter
- No Disturbance. No access to site except by authorised personnel
- Maintain 53ha designated SCI halophytic marsh community (this includes all Annex I Habitat Types of Habitat Directive) in Favourable Conservation Status
- No invasive non-native plant species present
- No increase to extent of reed (*Phragmites australis*) as mapped in 2014 (figure 4).
- No physical hazards on flight paths

Recommended methodology for the control of *Phragmites australis* (within SPA) where it has expanded from areas marked in figure 4.

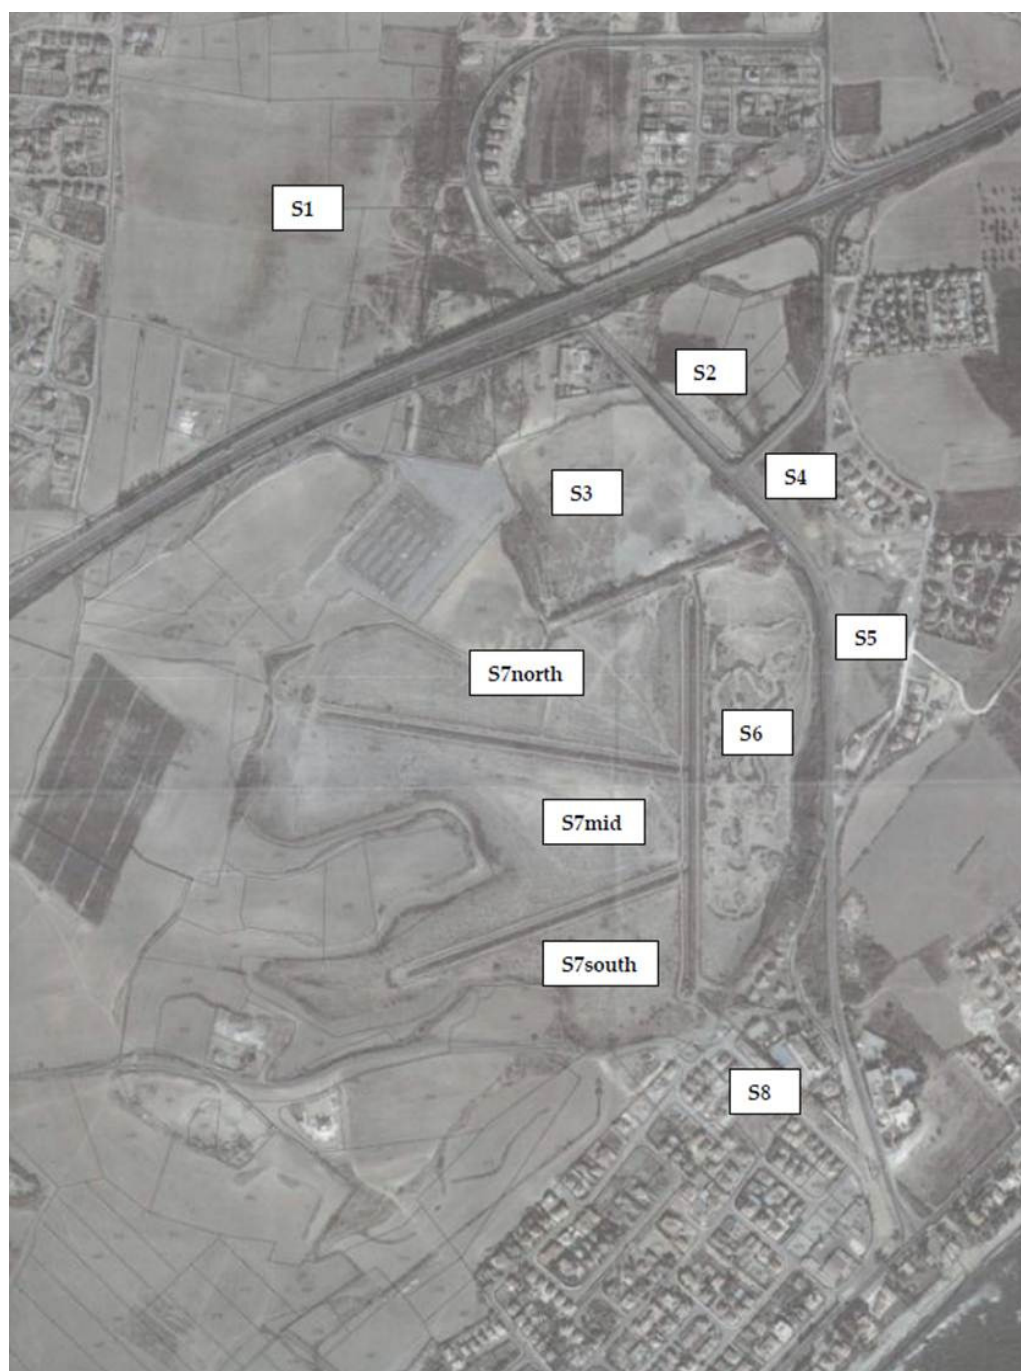
Figure 5: Map showing compartments of Oroklini SPA

The embankment holds water in S3 (figure 5) and separates this compartment from S6 & S7. The weir, at the eastern part of the embankment was revealed by the removal of dense vegetation in October 2012 and repaired in November 2013. The east wing wall of the weir had been partially removed in 2008 by members of the local community due to fears about the threat of Avian Flu. A section of the embankment was also restored following the identification of a partial slump in one section.

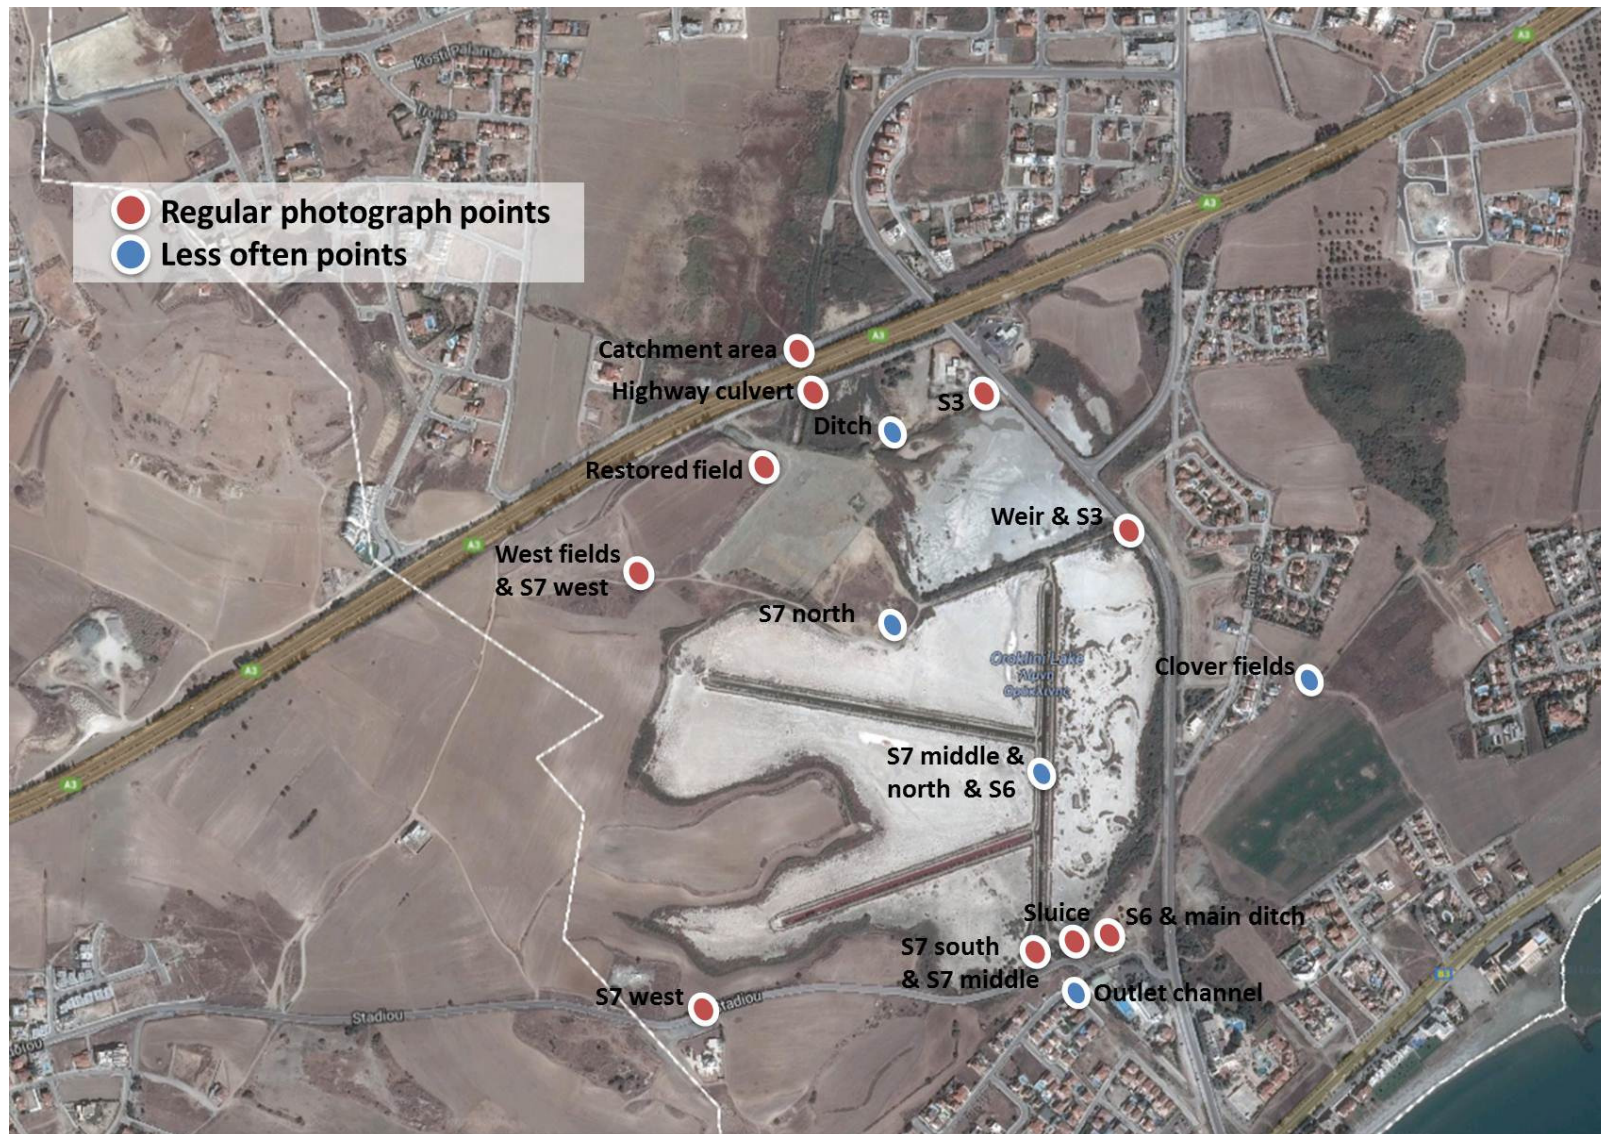
Figure 6: Locations used for fixed point photography

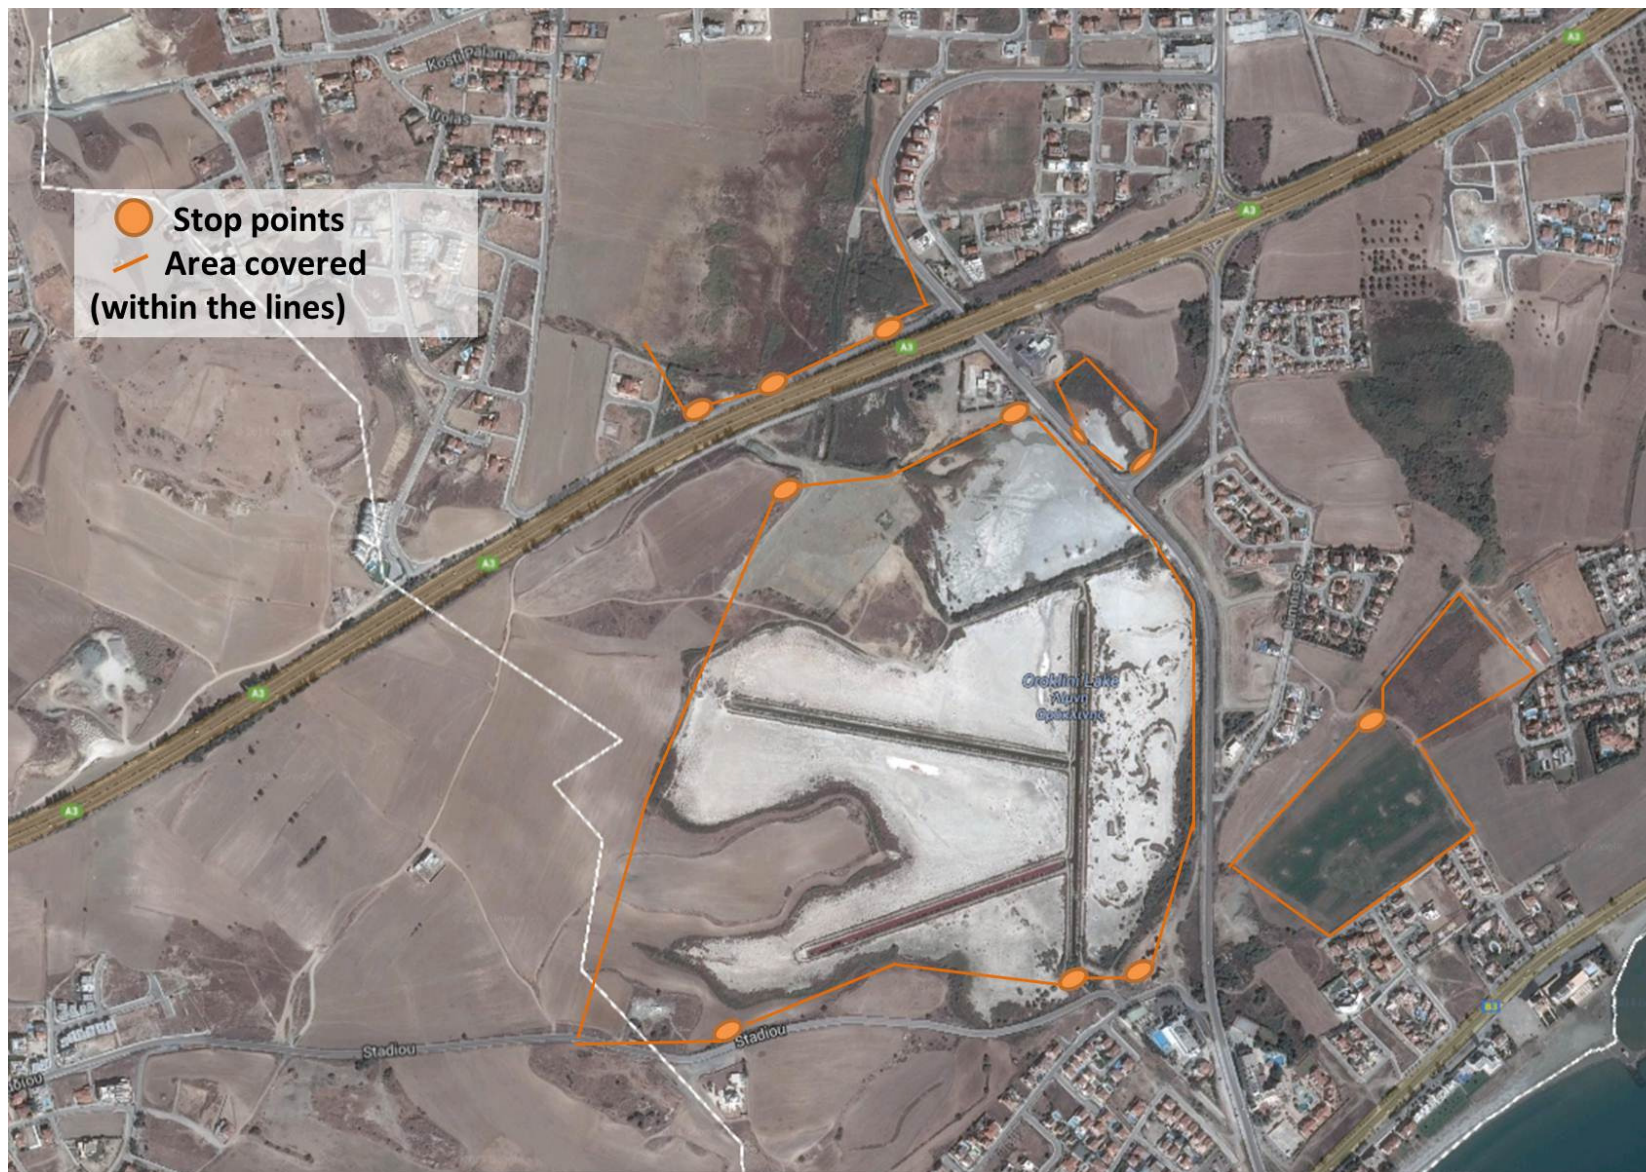
Figure 7: Current vantage point locations for regular wetland bird surveys, recommended for use with above methodologies

Terns should ideally be monitored by carrying out counts of **Apparently Incubating Adult terns** from vantage points (figure 7), providing that at least 80% of nests or incubating terns are thought to be visible. Other methods can be used, but all can cause considerable disturbance therefore specialist advice should be sought before attempting these.
