Oroklini Lake, Cyprus

Water Management Plan

April 2014

(ref: LIFE10 NAT CY 000716 OROKLINI)

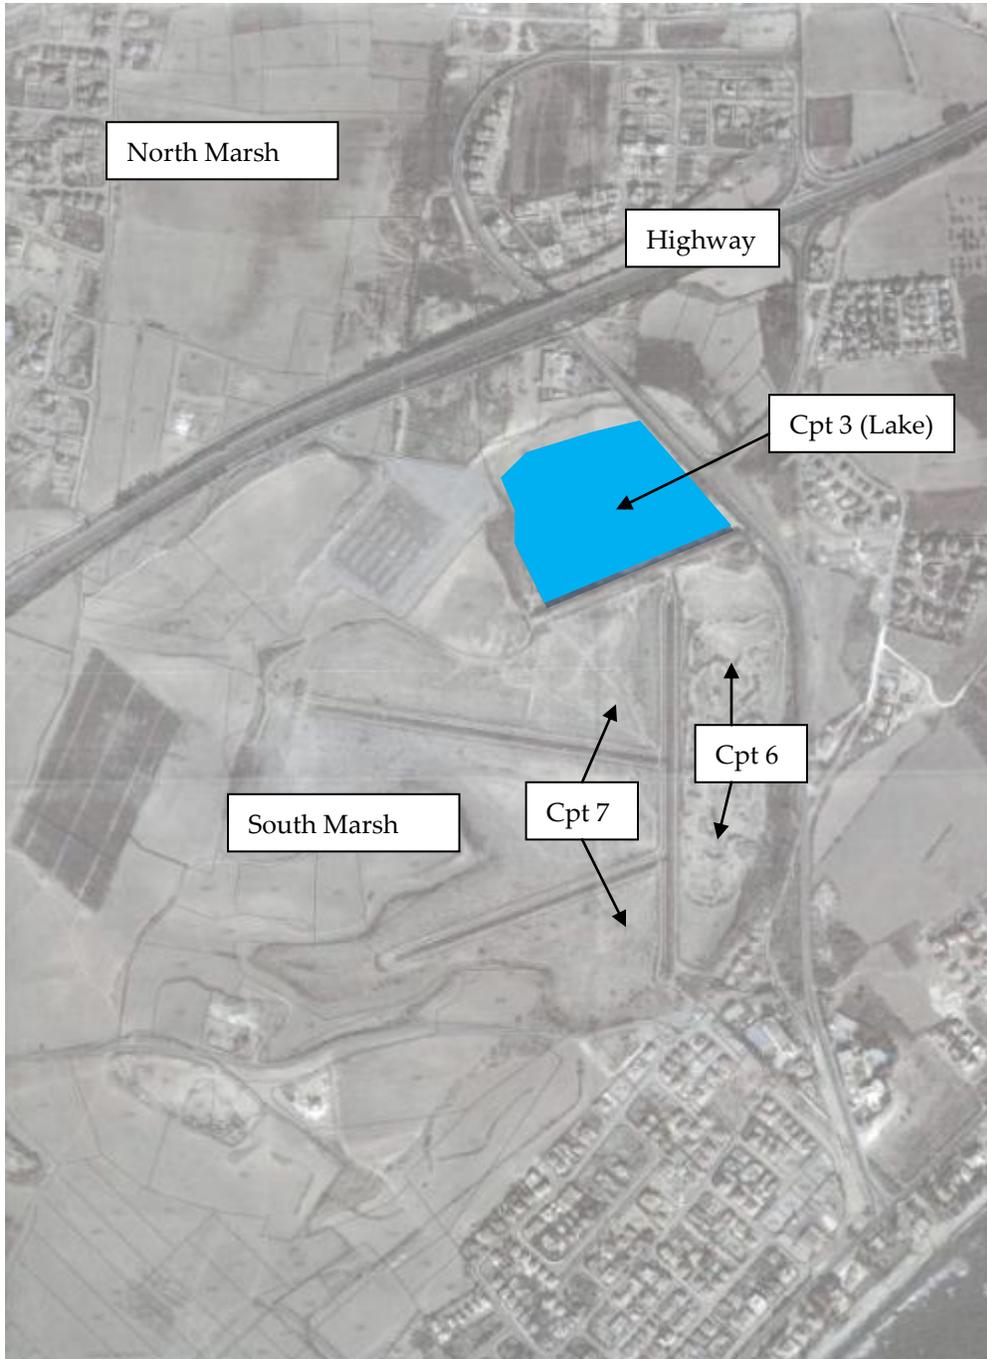
Oroklini Marsh key compartments

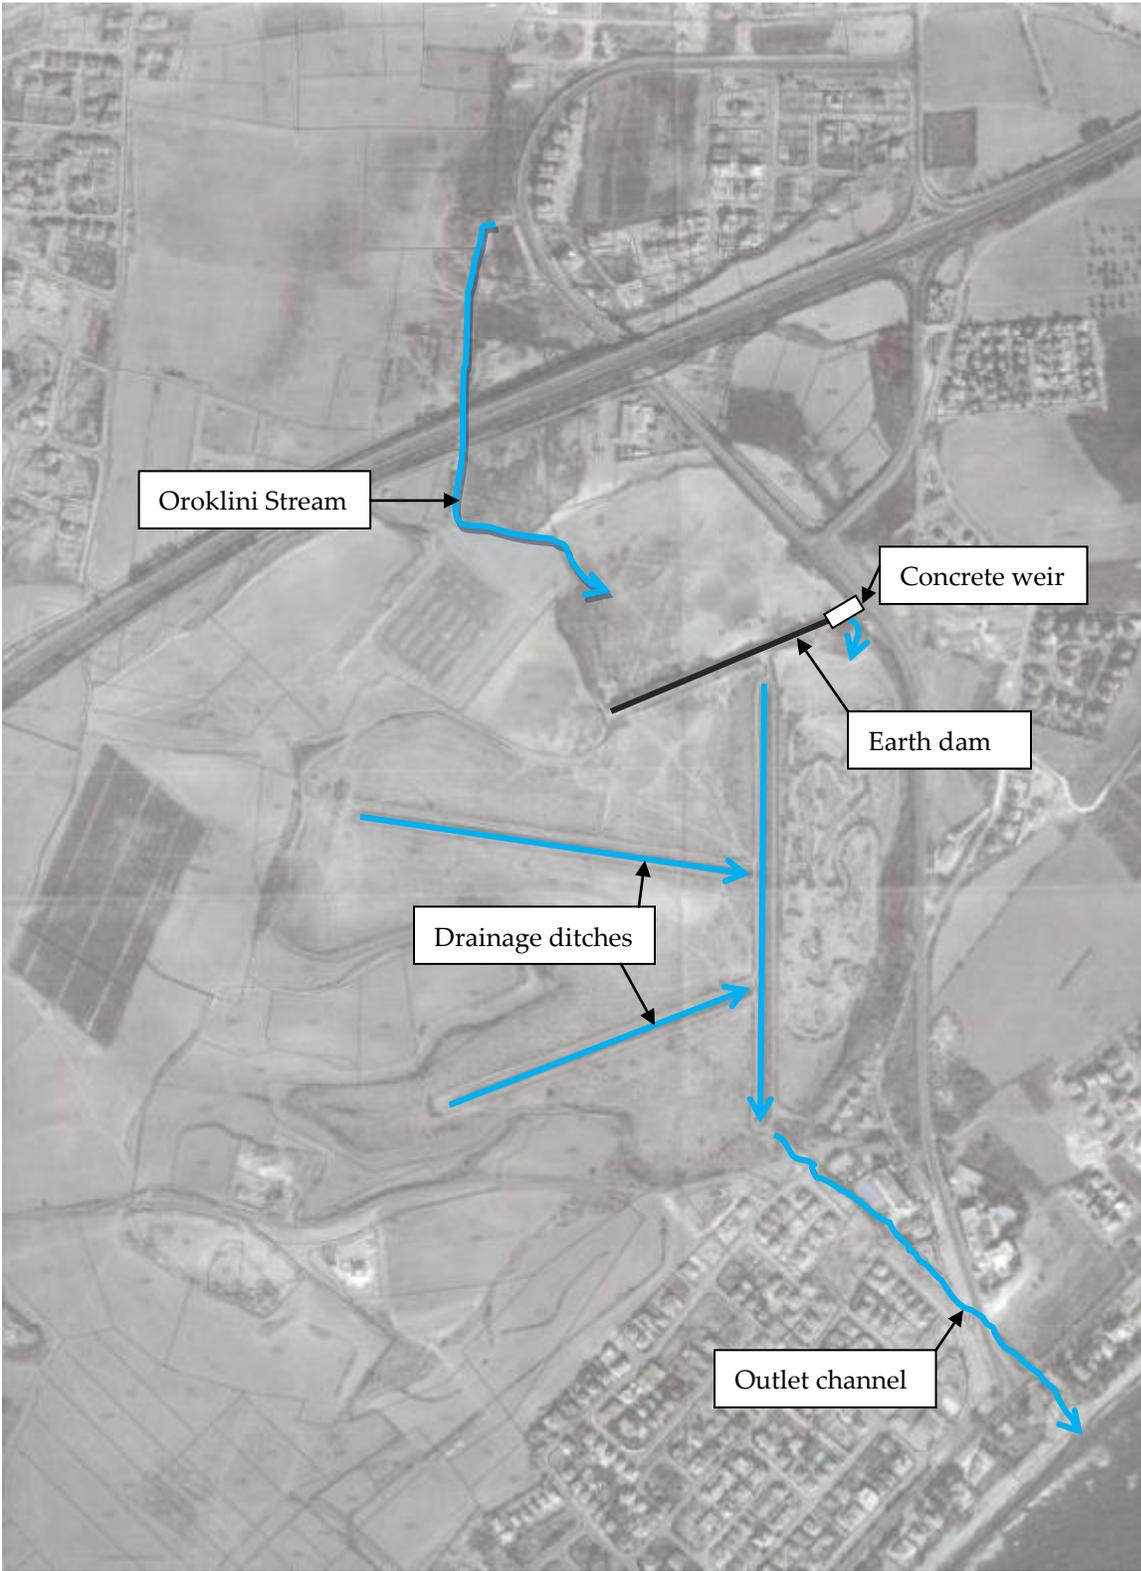
Oroklini Marsh - summary of key hydrological features

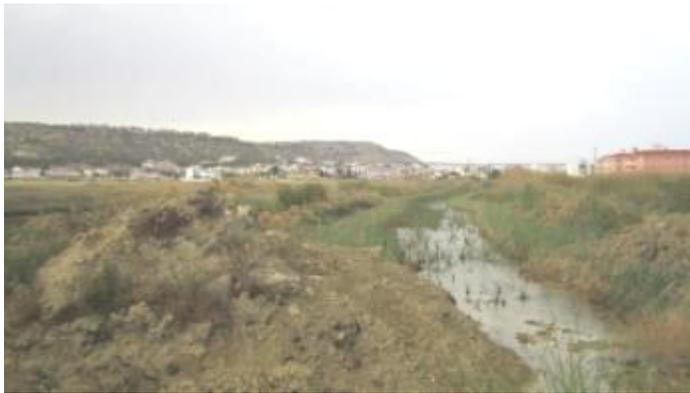
Northern Marsh, looking towards the north, showing recently cleared ditch

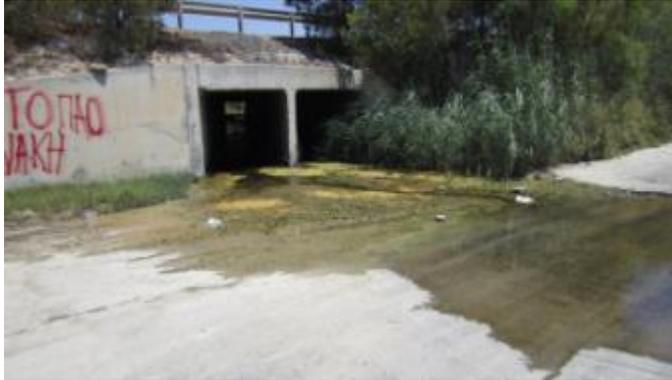
The main culvert under the highway, draining the northern marsh towards the south.

Water from this part of the site drains under the minor road to the north of the highway, then passes under the main highway in large twin culverts. A smaller flow from another culvert also passes under the highway at an angle from the north-west, discharging close to the ford on the minor road on the south side of the highway. The largest drainage ditch had recently been cleared of reed, widened and deepened on the east side of the marsh.

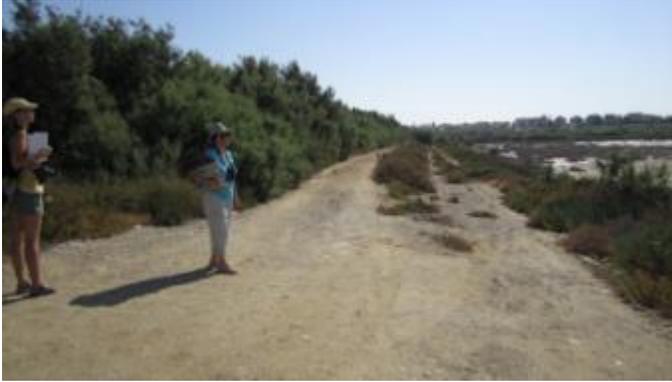
The dam on the south side of S3 looking from the west end.

I.A.Co. have carried out a survey of the integrity of the dam. The dam is wide and is generally in good condition despite being constructed of rock, concrete, and fine crushings, without the use of a binding agent. Vegetation (mostly tamarisk and reed) has grown densely along the dam, and particularly in and around the weir. It is possible that roots could weaken the dam structure and certainly make inspection and maintenance more difficult. Inspection by I.A.Co. has shown a point of minor leakage (170m from the west end) and a length of subsidence (0.4-0.5m) immediately to the west of this, as well as some evidence of minor overflowing, but the overall conclusion is that the dam is in good condition and more than adequate as a part of the water management infrastructure.

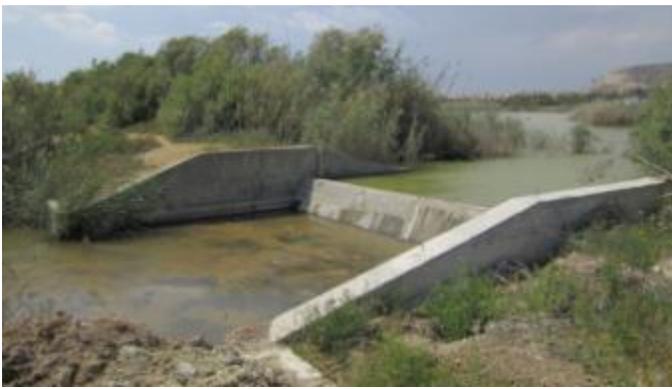
Compartment S3 weir viewed from the east side, with the new wing wall on near side

At the start of the LIFE project the weir at the easternmost end of the dam had been breached using a digger to drain S3 due to bird flu fears in 2008. S3 was reportedly drained in one day, and this water was quickly lost from S6 also. The breach was originally repaired using local infill material, but has since been completed using concrete construction with a crest elevation of approximately 20.00m asl (actual 19.96m asl).

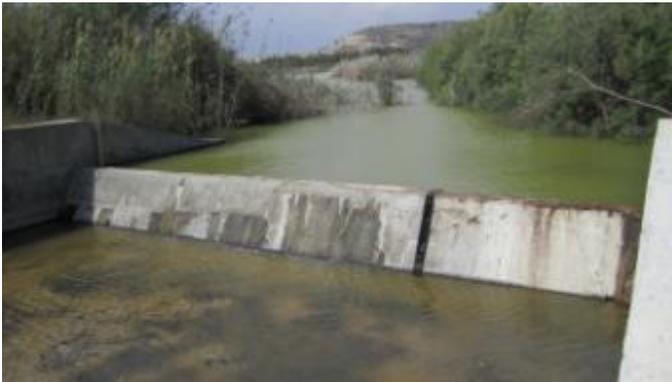
Detail of compartment S3 weir, showing rebuilt section of crest on east side

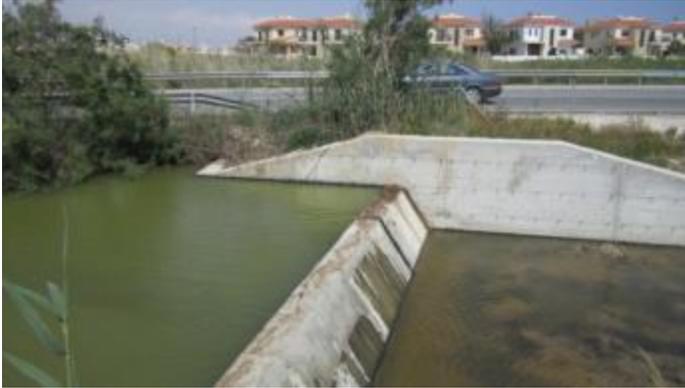
Rebuilt eastern weir and wing wall, with road behind

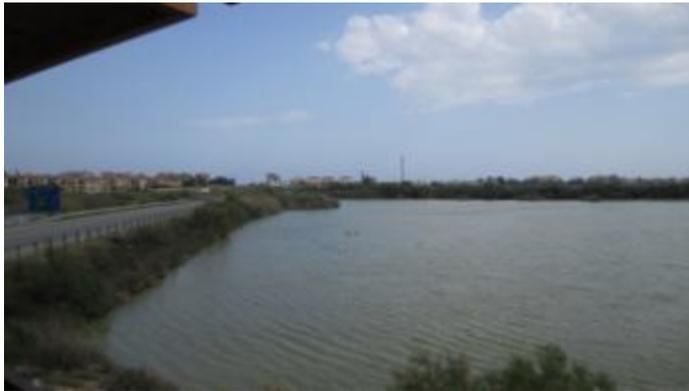
View over compartment S3 from new viewing hide, the weir is towards the far left corner, with water levels at approximately 20.0m asl.

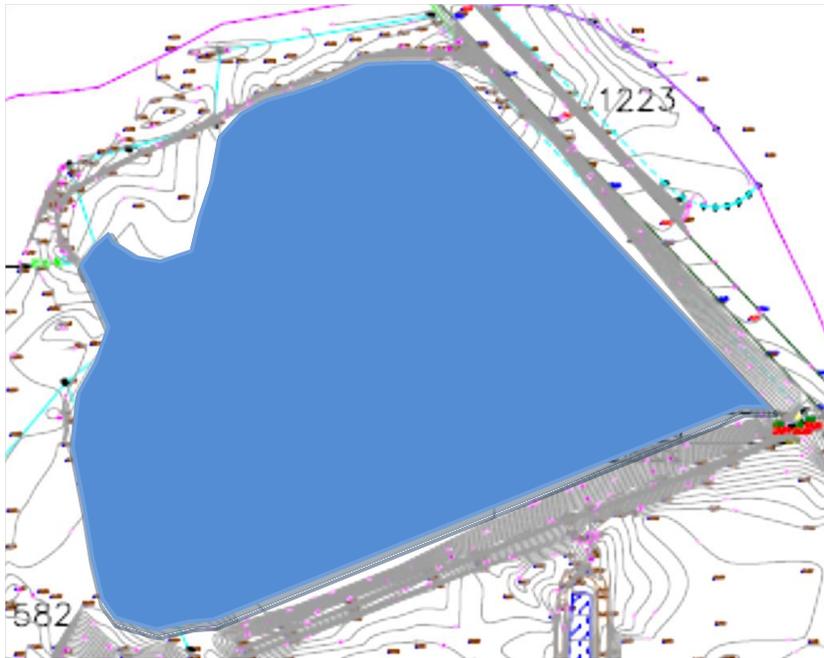
Compartment S3, water extent at approximate weir crest elevation of 20.0m, expected in late winter

In a typical year, winter rain and inputs from the Oroklini Stream will raise water levels in the compartment to the 20.0m asl weir crest height and then overflow. The 9m width of the weir and high wing walls permit a large overflow of storm water. I.A.Co. estimated that the weir has enough capacity to cope with a 1:100 year flood event without risking overtopping of the adjacent dam crest.

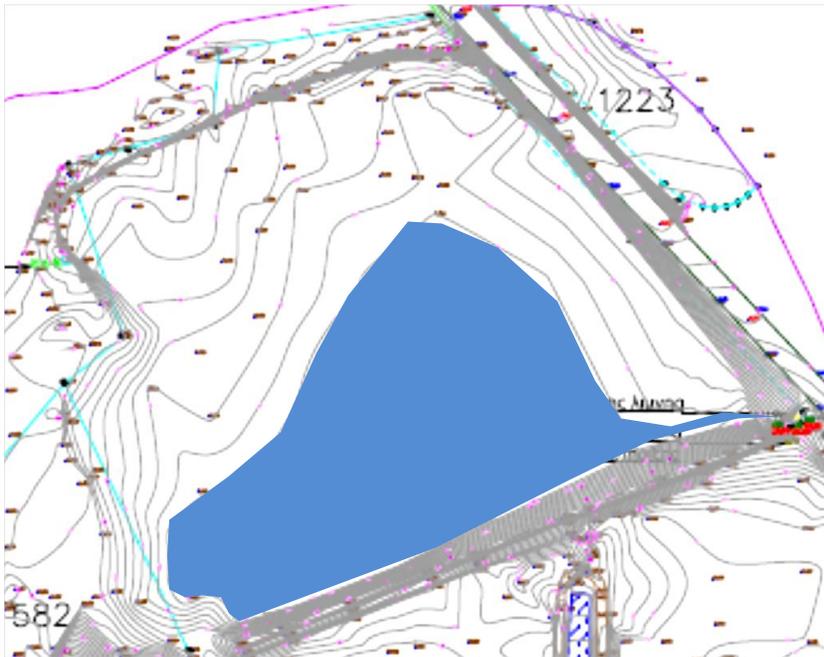
Compartment S3, water extent at 19.5m asl, expected by June in typical year.

Ground levels in compartment S3 vary from approximately 19.4m asl to in excess of 20.0m asl, particularly in the north west corner which has a broad band of mature reeds and a sinuous muddy margin. This means that at a typical late winter peak water level of 20.0m asl, water will cover around 85% of the compartment, with an additional 20% of the compartment with water less than 20cm deep, suitable for a broad range of waders (including black-winged stilt) and wildfowl. Evapotranspiration is likely to increase during the spring, from 1mm/ day in March to up to 6mm/day in June, resulting in a fall in water levels to approximately 19.55m asl, and covering approximately 40% of the compartment, much of which is less than 10cm deep. The retreating water level leaves an exposed muddy edge as it progresses.

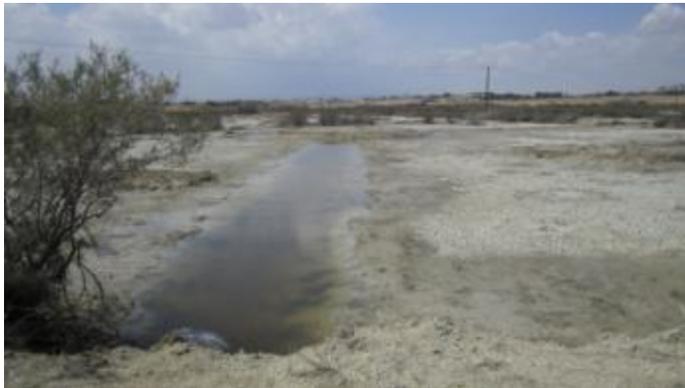
Compartment S7 (south) showing new island, ditch, and culvert connecting to the main drain, after an exceptionally dry winter and water levels below 18.7m asl.

In addition, a series of small islands (c10m diameter) were created using material excavated from new, gently-shelving ditches around each one and connected to the main drain. These islands are intended to provide nest sites secure from flood events, and with some protection in falling water conditions from predator and human access. The perimeter ditches also increase the length of feeding edge at a range of water levels. Vegetation was also removed from some existing islands to make them more attractive, particularly for breeding spur-winged lapwings and little terns. The ditches have been connected to adjacent main ditches so that they can be both supplied and drawn down, while allowing fish and eel access.

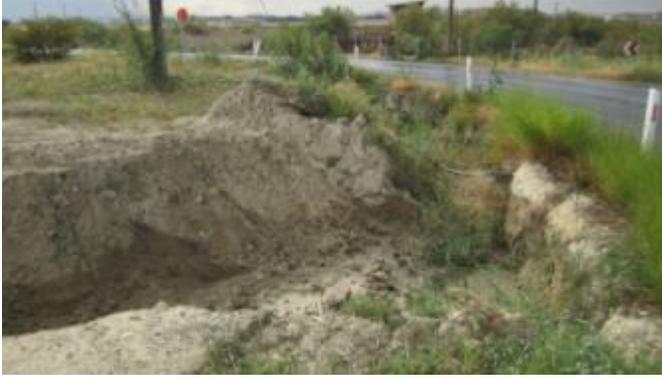
The curved channel and electricity pole to the south of the road

The drainage channel to the south of the road is functional, but follows an arc around an electricity pole before joining a recently cleared section before the substantial culvert pipes at the beginning of the concrete lined channel. These pipes have an invert level of 18.45m asl, so a further small fall. The curved ditch has steep and eroded sides and a loose electricity cable across it. High flows are likely to cause further erosion (and are more likely with the new outlet pipe and channel) and may endanger the electricity pole and cable.

Continue work to **improve the outflow channel** between the road culvert and concrete culverts and channels at the housing estate. At present this is a ditch around an electricity pylon, with a recently enlarged straight section, and reinforcement. The sides are eroding in high flow situations. There is also an cable draped across the ditch. This channel would ideally run straight from the road culvert to the major culverts to the south, but an underground cable makes this unlikely. A secondary solution is to retain the alignment around the pylon and reinforce the sides with concrete. Modular concrete liner sections could be used to line the channel, or constructed in situ. The culvert under the road could also be set lower to enhance outflow and prevent ponding in the channel.

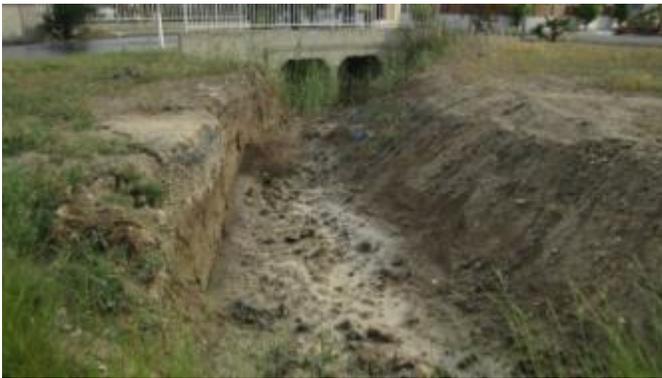
Newly cleared section before the large concrete channels leading to the sea

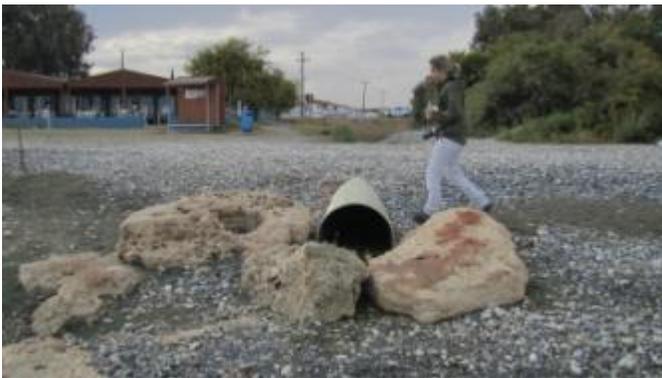
The final outlet to the sea, recently piped.

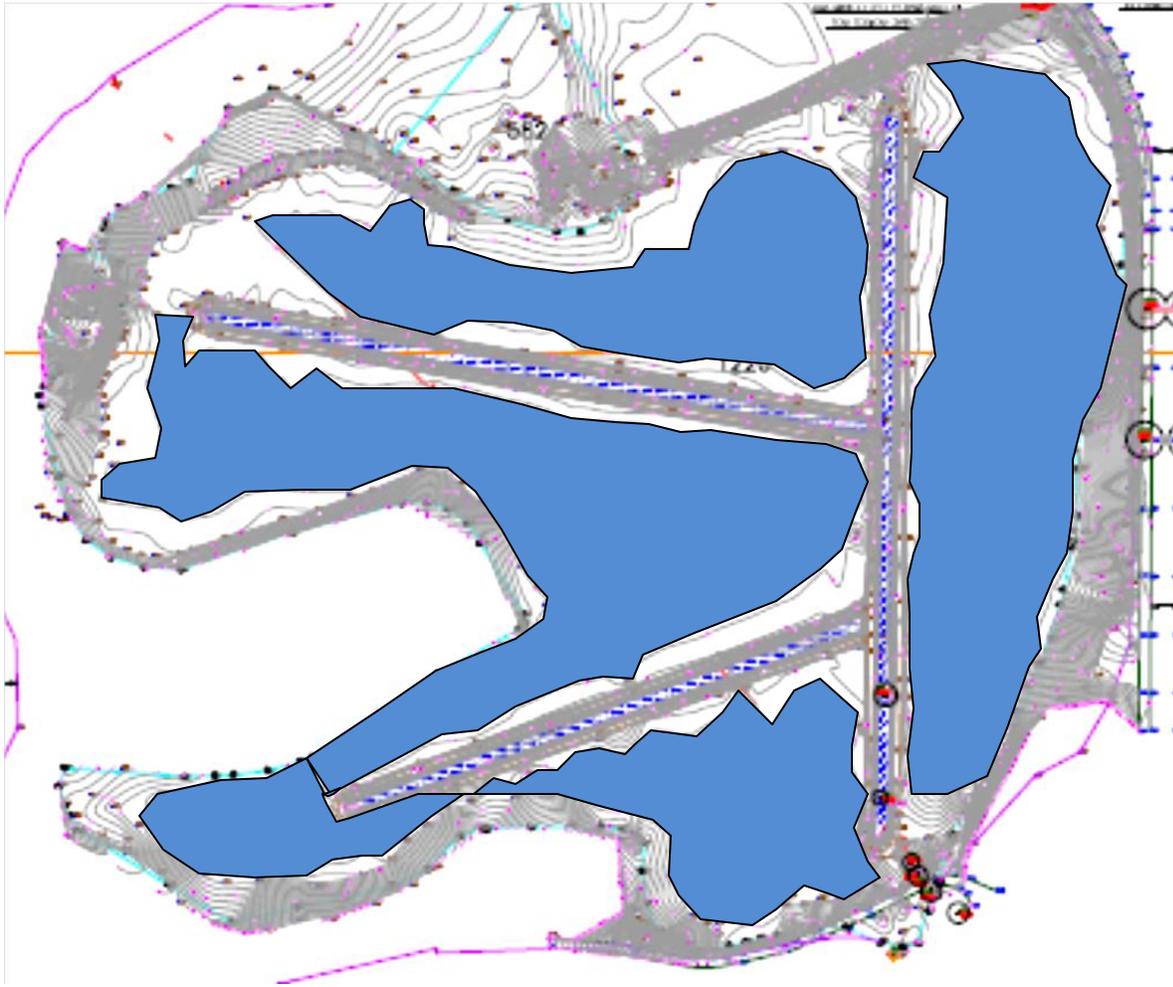
Compartments S7 and S6, cover of water at a level of 18.90m asl, a desirable level at the beginning of the breeding season

Ground levels in compartments S6 and S7 are typically 18.3m asl to 18.9m asl, with islands at around 19.2-19.8m asl. The lowest areas tend to be in the middle of S7 and in the centre of S6, and this is apparent as water levels fall in typical spring conditions. Most of these areas are around 18.4-18.6m asl but the lack of variation in ground levels results in a rather small water capacity at target levels, so much of the area is vulnerable to drying.

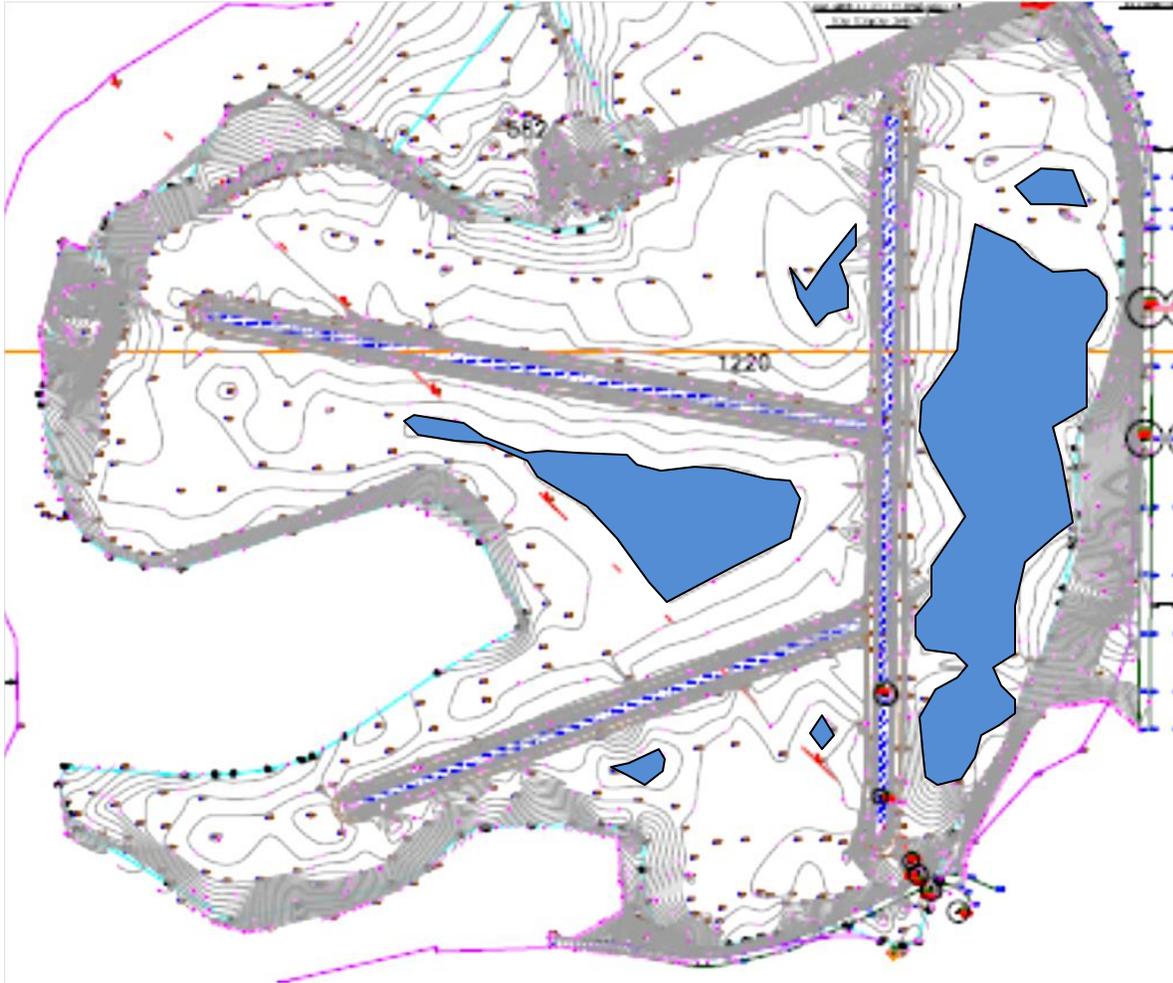
Compartments S7 and S6, cover of water at a level of 18.70m asl, a desirable level in the later part of the breeding season.

Evapotranspiration is likely to increase during the spring, from 1mm/ day in March to up to 6mm/day in June, resulting in a fall in water levels of approximately 3cm in March, 6cm in April, 12cm in May and 18cm in June, a total fall of 39cm (21cm by the end of May). A water level of around 18.7 and 18.8m asl is desirable in the latter part of the breeding season (late May) to provide significant areas of wet muddy edge and shallow open water adjacent to drier ground. With no freshwater inputs from compartment S3 or direct rainfall this would need a late winter water level of around 18.9-19.0m asl. In a normal year there is likely to be both surface input and some rainfall during this period.

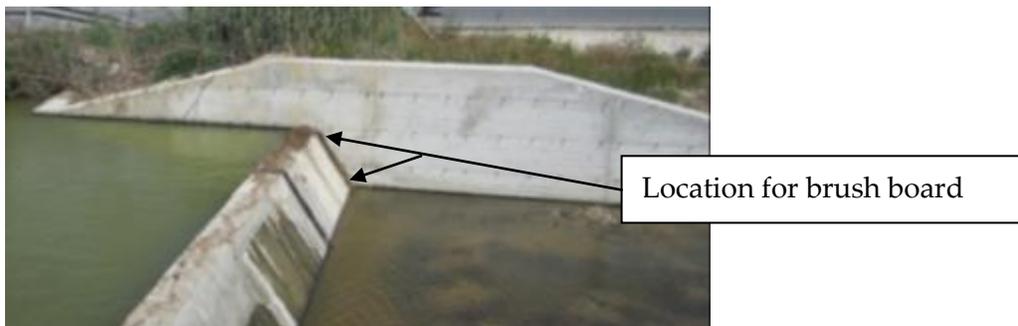
The angle between the weir face and the concrete wing wall. This eastern side is slightly lower than the west so will overflow for longer and is likely to be preferred by eels

Install an eel pass on the weir. Eels will benefit greatly from being able to move upstream into compartment S3 where there is the greatest chance of water being retained. Immature eels will tend to attempt to move up in the angle between the weir face and the wing wall. This can be facilitated by the installation of a 5-10cm width strip of climbing medium, preferably of the 'bristleboard' type, but loosely rolled garden mesh or Astroturf can also work. Even the heads of sweeping brushes screwed to the wing wall would work. The critical factors are to ensure it is right in the angle, and that there is a water flow through it (although this can be infrequent, as eels will move en masse in good conditions).

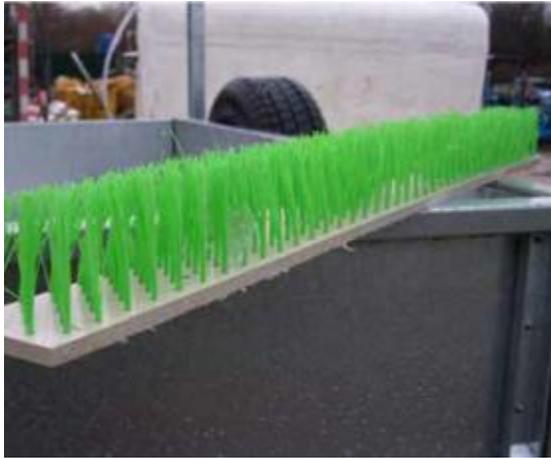
An example of bristleboard.

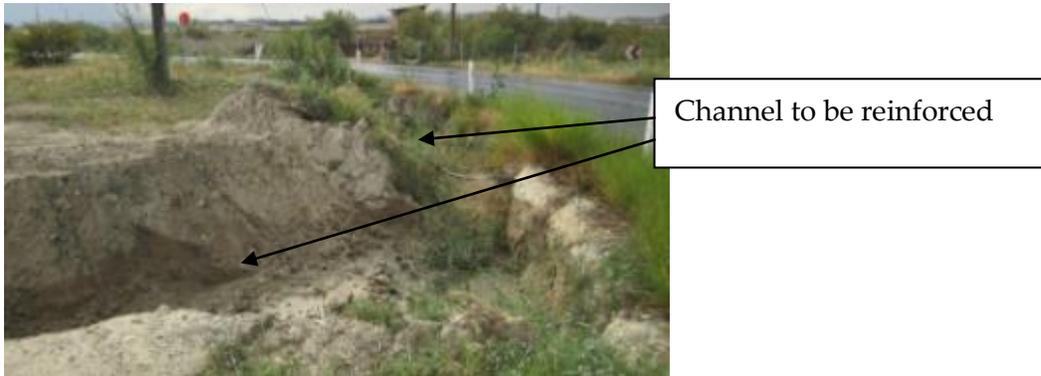
The outlet channel with recently enlarged section.
